Access Compliance Report

Public Rights-of-Way

(Curb Ramps)

Intersection ID: 10020375	Main Street: BALLANTYNE CORPORATE PL	Cross Street: N/A	Location: SW
ADA ID: D8F3B07248AA	Ramp Type: Perp	Initial Pass/Fail: Fail	Overall Compliance: No
Severity Score: 26.25			
Codes/Mitigation Info/Possible Solution		Field Measurements/Component Compliance

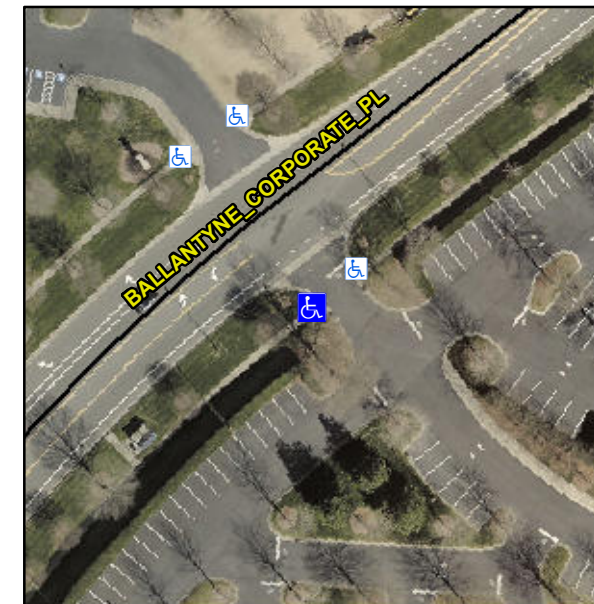
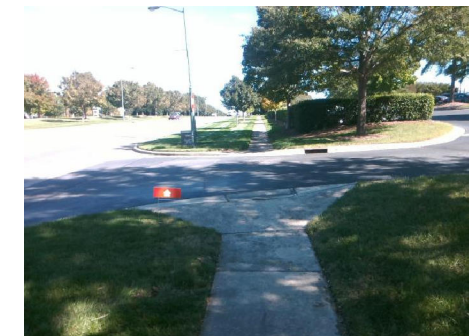
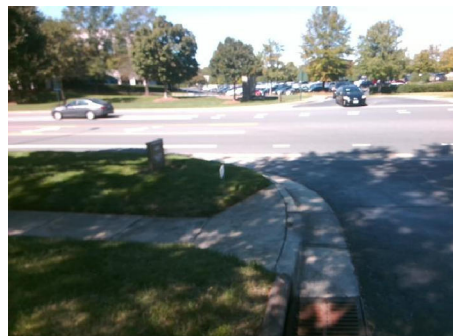
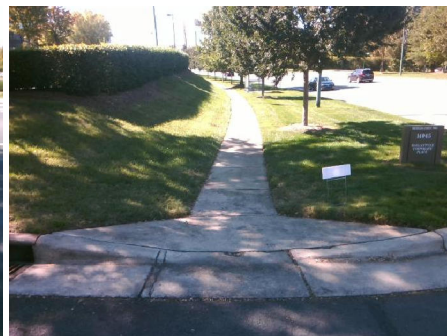
Compliance	Description	Data	Compliance	Description	Data
N/A	Ramp Length (in)	52.0	No	Ramp Slope (%)	14.9
Yes	Ramp Width (in)	48.0	No	Ramp XSlope (%)	2.9
N/A	Flare Type LT	N/A	N/A	Flare Type RT	N/A
N/A	Flare Slope LT (%)	N/A	N/A	Flare Slope RT (%)	N/A
N/A	Flare Traversable LT?	N/A	N/A	Flare Traversable RT?	N/A
N/A	Landing Length (in)	N/A	N/A	DWS Provided?	N/A
N/A	Landing Width (in)	N/A	N/A	DWS Contrast?	N/A
N/A	Landing Slope (%)	N/A	N/A	DWS Length (in)	N/A
N/A	Landing X Slope (%)	N/A	N/A	DWS Full Width?	N/A
N/A	Landing Curb? (Y/N)	N/A	N/A	DWS Offset (in)	N/A
N/A	Shared Landing?	N/A			
N/A	Gutter Ponding?	N/A	N/A	Gutter Slope (%)	N/A
N/A	Gutter Lip Ht (in)	N/A	N/A	Gutter X Slope (%)	N/A
N/A	Painted X Walk1?	No	N/A	Painted X Walk2?	N/A
	X Walk 1 Direction	To E		X Walk 2 Direction	N/A
N/A	X Walk 1 Width (in)	N/A	N/A	X Walk 2 Width (in)	N/A
	X Walk 1 Slope (%)	3.9		X Walk 2 Slope (%)	N/A
	X Walk 1 X Slope (%)	6.9		X Walk 2 X Slope (%)	N/A

N/A	Ramp inside XWalk1?	N/A	N/A	Ramp inside XWalk2?	N/A
	Road Slope (%)	N/A	N/A	Clear Space?	N/A
	Road X Slope (%)	N/A	N/A	Clear Space to XWalk (in)	N/A
N/A	Any Obstructions?	N/A	N/A	Storm Grate/Utility Hazard?	N/A
	Obstruction Type			Storm Grate/Utility Type	
		N/A			N/A
			Yes	Surface Condition? (G/P)	Good

Possible Solutions:

Remove & Replace Entire Ramp.

Total Cost: \$ 1850.00
