Access Compliance Report

Public Rights-of-Way

(Curb Ramps)

Intersection ID: 15800	Main Street: PROVIDENCE_RD	Cross Street: QUEENS_RD	Location: SE
ADA ID: D8F4108F0150	Ramp Type: PerpDiag	Initial Pass/Fail: Fail	Overall Compliance: No
Codes/Mitigation Info/Possible Solution		Field Measurements/Component Compliance	
Severity Score: 31.25

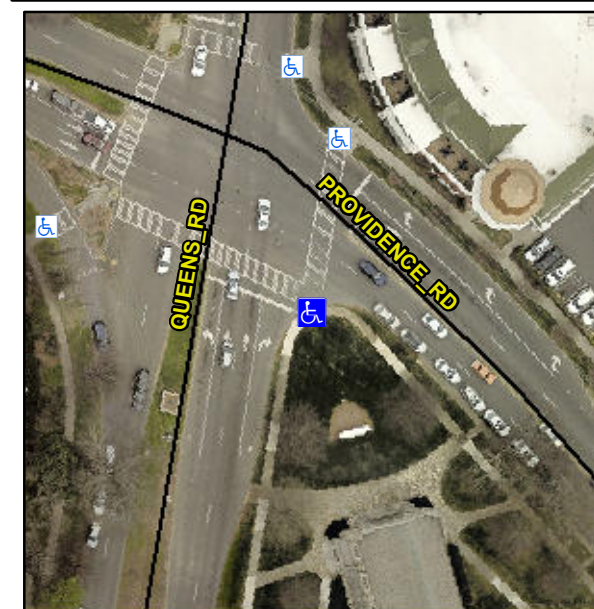
Compliance	Description	Data	Compliance	Description	Data
N/A	Ramp Length (in)	64.0	No	Ramp Slope (%)	9.7
No	Ramp Width (in)	35.0	No	Ramp XSlope (%)	3.1
N/A	Flare Type LT	N/A	N/A	Flare Type RT	N/A
N/A	Flare Slope LT (%)	N/A	N/A	Flare Slope RT (%)	N/A
N/A	Flare Traversable LT?	N/A	N/A	Flare Traversable RT?	N/A
N/A	Landing Length (in)	N/A	N/A	DWS Provided?	N/A
N/A	Landing Width (in)	N/A	N/A	DWS Contrast?	N/A
N/A	Landing Slope (%)	N/A	N/A	DWS Length (in)	N/A
N/A	Landing X Slope (%)	N/A	N/A	DWS Full Width?	N/A
N/A	Landing Curb? (Y/N)	N/A	N/A	DWS Offset (in)	N/A
N/A	Shared Landing?	N/A			
N/A	Gutter Ponding?	N/A	N/A	Gutter Slope (%)	N/A
N/A	Gutter Lip Ht (in)	N/A	N/A	Gutter X Slope (%)	N/A
N/A	Painted X Walk1?	Yes	N/A	Painted X Walk2?	Yes
	X Walk 1 Direction	To NE		X Walk 2 Direction	To NW
N/A	X Walk 1 Width (in)	112.0	N/A	X Walk 2 Width (in)	116.0
	X Walk 1 Slope (%)	4.7		X Walk 2 Slope (%)	2.3
	X Walk 1 X Slope (%)	0.9		X Walk 2 X Slope (%)	4.0

N/A	Ramp inside XWalk1?	Yes	N/A	Ramp inside XWalk2?	No
	Road Slope (%)	1.5	N/A	Clear Space?	N/A
	Road X Slope (%)	4.3	N/A	Clear Space to XWalk (in)	N/A
N/A	Any Obstructions?	N/A	N/A	Storm Grate/Utility Hazard?	N/A
	Obstruction Type			Storm Grate/Utility Type	
		N/A			N/A
		Yes		Surface Condition? (G/P)	Good

Remove & Replace Curb Ramp With Two New Directional Ramps or Equivalent. Restripe Crosswalk.
