Access Compliance Report Public Rights-of-Way (Curb Ramps)

Intersection ID: 15124Main Street: CHEROKEE_RDCross Street: S_LAUREL_AVLocation:EADA ID: D8F98F9BB4F7Ramp Type: PerpInitial Pass/Fail: FailOverall Compliance: NoSeverity Score: 12.5

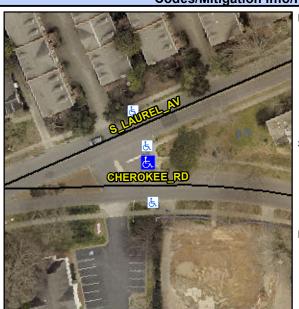
Field Measurements/Component Compliance									
Comp	liance Description	Data	Compl	iance	Description	Data			
N/A	Ramp Length (in)	96.0	No	Ramp	Slope (%)	10.2			
Yes	Ramp Width (in)	58.0	Yes	Ramp	XSlope (%)	0.2			
N/A	Flare Type LT	N/A	N/A	Flare	Type RT	N/A			
N/A	Flare Slope LT (%)	N/A	N/A	Flare	Slope RT (%)	N/A			
N/A	Flare Traversable LT?	N/A	N/A	Flare	Traversable RT?	N/A			
N/A	Landing Length (in)	N/A	N/A	DWS	Provided?	N/A			
N/A	Landing Width (in)	N/A	N/A	DWS	Contrast?	N/A			
N/A	Landing Slope (%)	N/A	N/A	DWS	Length (in)	N/A			
N/A	Landing X Slope (%)	N/A	N/A	DWS	Full Width?	N/A			
N/A	Landing Curb? (Y/N)	N/A	N/A	DWS	Offset (in)	N/A			
N/A	Shared Landing?	N/A							
N/A	Gutter Ponding?	N/A	N/A	Gutte	r Slope (%)	N/A			
N/A	Gutter Lip Ht (in)	N/A	N/A	Gutte	r X Slope (%)	N/A			
N/A	Painted X Walk1?	No	N/A	Paint	ed X Walk2?	N/A			
	X Walk 1 Direction	To S		X Wa	lk 2 Direction	N/A			
N/A	X Walk 1 Width (in)	N/A	N/A	X Wa	lk 2 Width (in)	N/A

X Walk 1 Slope (%)	7.2		X Wa	lk 2 Slope (%)	N/A			
	X Walk 1 X Slope (%)	3.4		X Wa	lk 2 X Slope (%)	N/A			
N/A	Ramp inside XWalk1?	N/A	N/A	Ramp	inside XWalk2?	N/A			
	Road Slope (%)	N/A	N/A	Clear	Space?	N/A			
	Road X Slope (%)	N/A	N/A	Clear	Space to XWalk (in)	N/A			
N/A	Any Obstructions?	N/A	N/A	Storm	n Grate/Utility Hazard?	N/A			
	Obstruction Type			Storm	n Grate/Utility Type				
		N/A				N/A			
			Yes	Surfa	ce Condition? (G/P)	Good

Possible Solutions:	Co
Remove & Replace Entire Ramp.	N/A
·	Ye
	N/A
	N/A
	N/A
	N/A
Surveyor Notes:	N/A
N/A	N/A
	N/A
	N/A
	N/A
PROW/ADA:	N/A
Not Found, R304.2.2	N/A
·	N/A
	N/A
	N//
