## **Access Compliance Report Public Rights-of-Way** (Curb Ramps)

Intersection ID: 28270 Main Street: PEMSWOOD ST Cross Street: SUMMER\_CLUB\_RD Location: W ADA ID: D90B5C9C721F Ramp Type: PerpDiag Initial Pass/Fail: Fail **Overall Compliance: No Severity Score:** 17.5

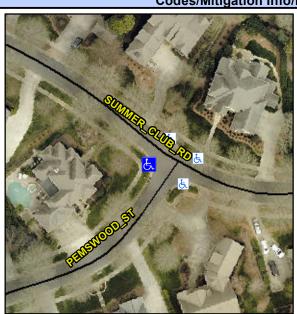
Compliance Description Data Compliance Description Data					
N/A	Ramp Length (in)	150.0	Yes	Ramp Slope (%)	5.2
No	Ramp Width (in)	34.0	Yes	Ramp XSlope (%)	1.0
N/A	Flare Type LT	N/A	N/A	Flare Type RT	N/A
N/A	Flare Slope LT (%)	N/A	N/A	Flare Slope RT (%)	N/A
N/A	Flare Traversable LT?	N/A	N/A	Flare Traversable RT?	N/A
N/A		N/A N/A	N/A N/A	DWS Provided?	N/A N/A
	Landing Length (in)				
N/A	Landing Width (in)	N/A	N/A	DWS Contrast?	N/A
N/A	Landing Slope (%)	N/A	N/A	DWS Length (in)	N/A
N/A	Landing X Slope (%)	N/A	N/A	DWS Full Width?	N/A
N/A	Landing Curb? (Y/N)	N/A	N/A	DWS Offset (in)	N/A
N/A	Shared Landing?	N/A			
N/A	Gutter Ponding?	N/A	N/A	Gutter Slope (%)	N/A
N/A	Gutter Lip Ht (in)	N/A	N/A	Gutter X Slope (%)	N/A
N/A	Painted X Walk1?	No	N/A	Painted X Walk2?	No
	X Walk 1 Direction	To SE		X Walk 2 Direction	To NE
N/A	X Walk 1 Width (in)	N/A	N/A	X Walk 2 Width (in)	N/A
	X Walk 1 Slope (%)	1.2		X Walk 2 Slope (%)	2.3

X Walk 1 X Slope (%)	0.8		X Walk 2 X Slope (%)	2.5
N/A	Ramp inside XWalk1?	N/A	N/A	Ramp inside XWalk2?	N/A
	Road Slope (%)	2.9	N/A	Clear Space?	N/A
	Road X Slope (%)	0.2	N/A	Clear Space to XWalk (in)	N/A
N/A	Any Obstructions?	N/A	N/A	Storm Grate/Utility Hazard?	N/A
	Obstruction Type			Storm Grate/Utility Type	
	,,	N/A		- 7 71	N/A
			Yes	Surface Condition? (G/P)	Good
				Sandos Condition: (O/I )	0000

Possible Solutions: Remove & Replace Curb Ramp With Two New Directional Ramps or Equivalent. Surveyor Notes: N/A

PROW/ADA: R304.5.1
