Access Compliance Report

Public Rights-of-Way

(Curb Ramps)

Intersection ID: N/A	Main Street: S_CALDWELL_ST	Cross Street: E_STONEWALL_ST	Location: S
ADA ID: D90D915CEE1	Ramp Type: BlendTrans1	Initial Pass/Fail: Pass	Overall Compliance: No
Severity Score: 0			
Codes/Mitigation Info/Possible Solution		Field Measurements/Component Compliance

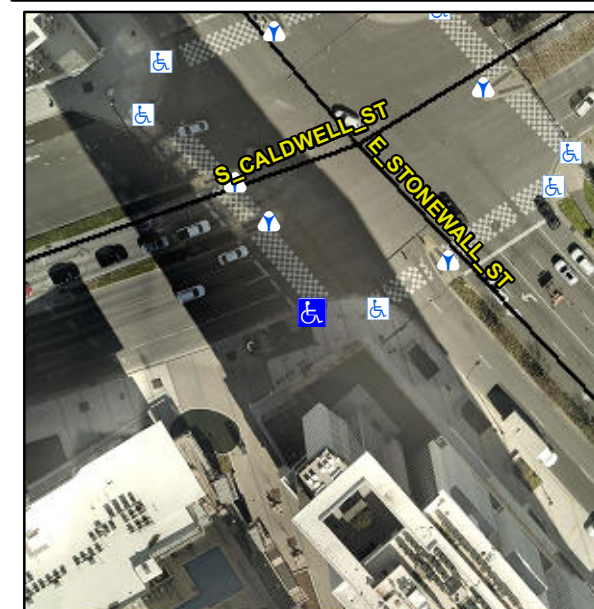
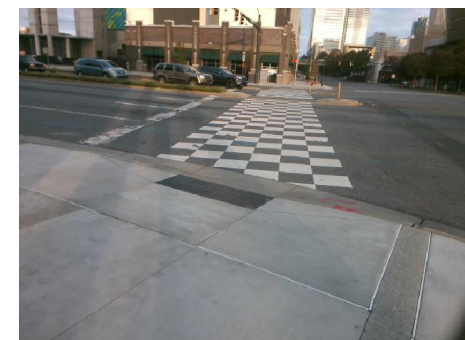
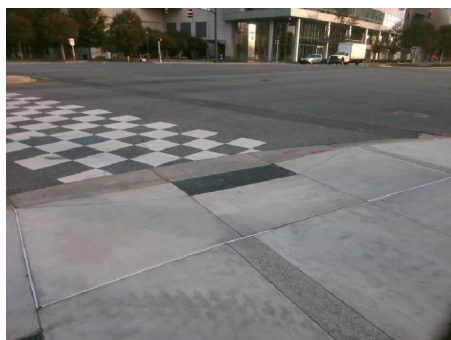
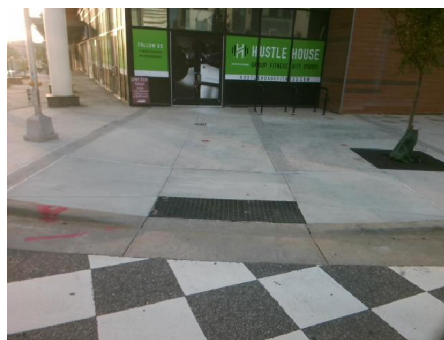
Compliance	Description	Data	Compliance	Description	Data
N/A	Ramp Length (in)	72.0	Yes	BlendTrans Slope (%)	1.7
Yes	Ramp Width (in)	69.0	Yes	BlendTrans XSlope (%)	0.9
N/A	Flare Type LT	Sloped	N/A	Flare Type RT	Sloped
N/A	Flare Slope LT (%)	7.5	N/A	Flare Slope RT (%)	1.0
N/A	Flare Traversable LT?	No	N/A	Flare Traversable RT?	No
Yes	Landing Length (in)	60.0	Yes	DWS Provided?	Yes
Yes	Landing Width (in)	60.0	Yes	DWS Contrast?	Yes
Yes	Landing Slope (%)	0.2	Yes	DWS Length (in)	24.0
Yes	Landing X Slope (%)	0.9	Yes	DWS Full Width?	Yes
N/A	Landing Curb? (Y/N)	No	Yes	DWS Offset (in)	1.0
N/A	Shared Landing?	No			
Yes	Gutter Ponding?	No	Yes	Gutter Slope (%)	0.6
Yes	Gutter Lip Ht (in)	0.0	Yes	Gutter X Slope (%)	0.9
N/A	Painted X Walk1?	Yes	N/A	Painted X Walk2?	N/A
	X Walk 1 Direction	To NW		X Walk 2 Direction	N/A
	X Walk 1 Width (in)	144.0		X Walk 2 Width (in)	N/A
	X Walk 1 Slope (%)	0.6		X Walk 2 Slope (%)	N/A
	X Walk 1 X Slope (%)	1.9		X Walk 2 X Slope (%)	N/A

Yes	Ramp inside XWalk1?	Yes	N/A	Ramp inside XWalk2?	N/A
	Road Slope (%)	1.9		Clear Space?	Yes
	Road X Slope (%)	0.6	N/A	Clear Space to XWalk (in)	N/A
Yes	Any Obstructions?	No	Yes	Storm Grate/Utility Hazard?	No
	Obstruction Type			Storm Grate/Utility Type	
		N/A			N/A
			Yes	Surface Condition? (G/P)	Good
			No	Curb Slope (%)	9.2

Possible Solutions:

Remove & Replace Curb Slope and Extend Ramp.
