## **Access Compliance Report Public Rights-of-Way** (Curb Ramps)

Intersection ID: N/A Main Street: WILORA LAKE RD **Cross Street: N/A** Location: SE ADA ID: D90EC19FA20B Ramp Type: PerpDiag Initial Pass/Fail: Fail **Overall Compliance: No Severity Score:** 37.5

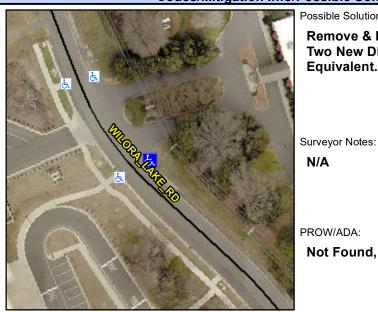
Compliance Description		Data	Compliance		Description	Data
N/A	Ramp Length (in)	48.5	No	Ramp	Slope (%)	14.2
Yes	Ramp Width (in)	55.0	No	Ramp	XSlope (%)	5.2
N/A	Flare Type LT	N/A	N/A	Flare	Type RT	N/A
N/A	Flare Slope LT (%)	N/A	N/A	Flare	Slope RT (%)	N/A
N/A	Flare Traversable LT?	N/A	N/A	Flare	Traversable RT?	N/A
N/A	Landing Length (in)	N/A	N/A	DWS	Provided?	N/A
N/A	Landing Width (in)	N/A	N/A	DWS	Contrast?	N/A
N/A	Landing Slope (%)	N/A	N/A	DWS	Length (in)	N/A
N/A	Landing X Slope (%)	N/A	N/A	DWS	Full Width?	N/A
N/A	Landing Curb? (Y/N)	N/A	N/A	DWS	Offset (in)	N/A
N/A	Shared Landing?	N/A				
N/A	Gutter Ponding?	N/A	N/A	Gutte	r Slope (%)	N/A
N/A	Gutter Lip Ht (in)	N/A	N/A	Gutte	r X Slope (%)	N/A
N/A	Painted X Walk1?	No	N/A	Paint	ed X Walk2?	No
	X Walk 1 Direction	To N		X Wa	lk 2 Direction	To W
N/A	X Walk 1 Width (in)	N/A	N/A	X Wa	lk 2 Width (in)	N/A
	X Walk 1 Slope (%)	0.2		X Wa	lk 2 Slope (%)	16.2
	X Walk 1 X Slope (%)	6.0		X Wa	lk 2 X Slope (%)	1.1

N/A	Ramp inside XWalk1?	N/A	N/A	Ramp	inside XWalk2?	N/A
	Road Slope (%)	4.3	N/A	Clear	Space?	N/A
	Road X Slope (%)	5.1	N/A	Clear	Space to XWalk (in)	N/A
N/A	Any Obstructions?	N/A	N/A	Storm	n Grate/Utility Hazard?	N/A
	Obstruction Type			Storm	Grate/Utility Type	
		N/A				N/A

Possible Solutions: Remove & Replace Curb Ramp With Two New Directional Ramps or Equivalent.

Not Found, R304.2.2, R304.5.3
