Access Compliance Report

Public Rights-of-Way

(Curb Ramps)

Intersection ID: 24925	Main Street: BIRNEN_DR	Cross Street: GLEN_LAUREL_WY	Location: NE
ADA ID: D90EDE5121EC	Ramp Type: PerpDiag	Initial Pass/Fail: Fail	Overall Compliance: No
		Severity Score: 12.5

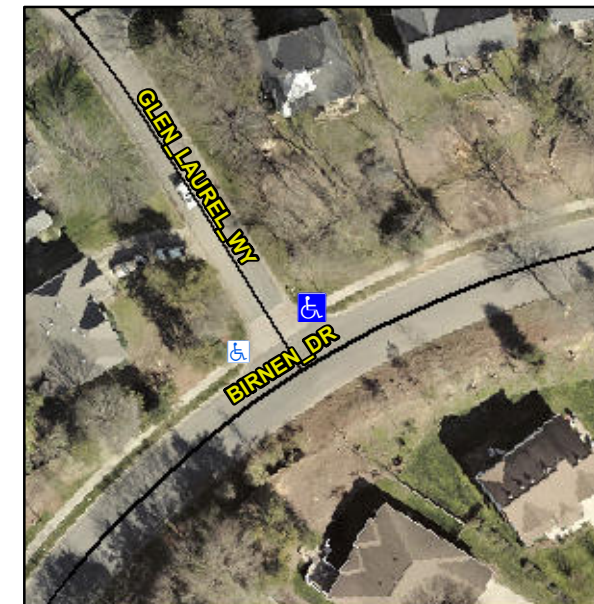
Not Found, R304.2.2

Compliance	Description	Data	Compliance	Description	Data
N/A	Ramp Length (in)	71.0	No	Ramp Slope (%)	9.1
Yes	Ramp Width (in)	49.0	Yes	Ramp XSlope (%)	1.1
N/A	Flare Type LT	N/A	N/A	Flare Type RT	N/A
N/A	Flare Slope LT (%)	N/A	N/A	Flare Slope RT (%)	N/A
N/A	Flare Traversable LT?	N/A	N/A	Flare Traversable RT?	N/A
N/A	Landing Length (in)	N/A	N/A	DWS Provided?	N/A
N/A	Landing Width (in)	N/A	N/A	DWS Contrast?	N/A
N/A	Landing Slope (%)	N/A	N/A	DWS Length (in)	N/A
N/A	Landing X Slope (%)	N/A	N/A	DWS Full Width?	N/A
N/A	Landing Curb? (Y/N)	N/A	N/A	DWS Offset (in)	N/A
N/A	Shared Landing?	N/A			
N/A	Gutter Ponding?	N/A	N/A	Gutter Slope (%)	N/A
N/A	Gutter Lip Ht (in)	N/A	N/A	Gutter X Slope (%)	N/A
N/A	Painted X Walk1?	No	N/A	Painted X Walk2?	No
	X Walk 1 Direction	To SW		X Walk 2 Direction	To S
N/A	X Walk 1 Width (in)	N/A	N/A	X Walk 2 Width (in)	N/A
	X Walk 1 Slope (%)	3.2		X Walk 2 Slope (%)	6.2
	X Walk 1 X Slope (%)	4.0		X Walk 2 X Slope (%)	4.0

N/A	Ramp inside XWalk1?	N/A	N/A	Ramp inside XWalk2?	N/A
	Road Slope (%)	0.1	N/A	Clear Space?	N/A
	Road X Slope (%)	5.4	N/A	Clear Space to XWalk (in)	N/A
N/A	Any Obstructions?	N/A	N/A	Storm Grate/Utility Hazard?	N/A
	Obstruction Type			Storm Grate/Utility Type	
		N/A			N/A
			Yes	Surface Condition? (G/P)	Good

Remove & Replace Curb Ramp With Two New Directional Ramps or Equivalent.

Total Cost: \$ 3200.00
