Access Compliance Report

Public Rights-of-Way

(Curb Ramps)

Intersection ID: 10020374		Main Street: BALLANTYNE CORPORATE PCross Street: N/A		Location: N															
ADA ID: D924A3600F56		Ramp Type: Directional1		Initial Pass/Fail: Fail		Overall Compliance: No		Severity Score: 1.25											
Codes/Mitigation Info/Possible Solution				Field Measurements/Component Compliance															
<div>

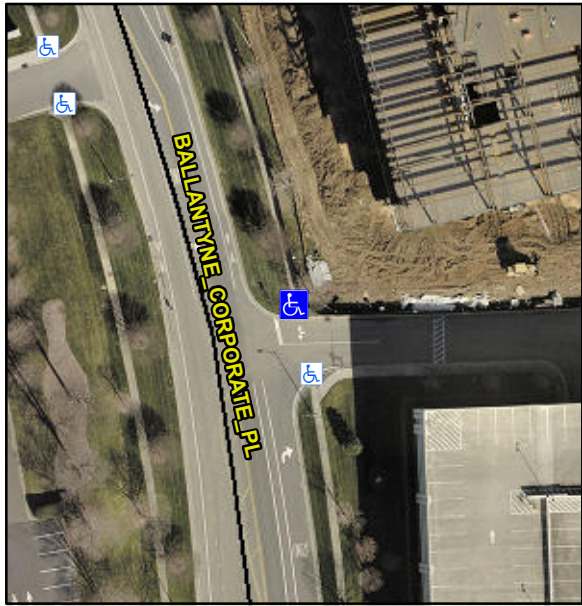
</div> <div>Street 1 NameENTRANCE</div> <div>Stop Condition-Street 1StopSign</div> <div>Street 2 NameN/A</div> <div>Stop Condition-Street 2N/A</div>				Possible Solutions:		Compliance		Description		Data		Compliance		Description		Data			
				Remove & Replace Entire Ramp.		N/A		Ramp Length (in)		77.0		N/A		Grade Break?		N/A		N/A	
						Yes		Ramp Width (in)		48.0		N/A		Grade Break Slope (%)		0.0		0.0	
						Yes		Ramp Slope (%)		2.2		N/A		Grade Break XSlope (%)		0.0		0.0	
						No		Ramp XSlope (%)		4.1									
						N/A		Flare Type LT		N/A		N/A		Flare Type RT		N/A		N/A

N/A		Flare Slope LT (%)		N/A		N/A		Flare Slope RT (%)		0.0		0.0	
						N/A		Flare Traversable LT?		N/A		N/A		Flare Traversable RT?		N/A		N/A	
						N/A		Landing Length (in)		0.0		N/A		DWS Provided?		N/A		N/A	
						N/A		Landing Width (in)		0.0		N/A		DWS Contrast?		N/A		N/A	
						N/A		Landing Slope (%)		0.0		N/A		DWS Length (in)		N/A		N/A	
						N/A		Landing X Slope (%)		0.0		N/A		DWS Full Width?		N/A		N/A	
						N/A		Landing Curb? (Y/N)		N/A		N/A		DWS Offset LT (in)		N/A		N/A	
						N/A		Shared Landing?		N/A		N/A		DWS Offset RT (in)		N/A		N/A	
						N/A		Gutter Ponding?		0.0		N/A		Gutter Slope (%)		N/A		N/A	
						N/A		Gutter Lip Ht (in)		0.0		N/A		Gutter X Slope (%)		N/A		N/A	
						N/A		Painted X Walk1?		No				Road Slope (%)		1.8		1.8	
								X Walk 1 Direction		To SE				Road X Slope (%)		4.9		4.9	
								X Walk 1 Width (in)		N/A				Clear Space?		N/A		N/A	
								X Walk 1 Slope (%)		1.8		N/A		Clear Space to XWalk (in)		N/A		N/A

X Walk 1 X Slope (%)		4.9		N/A		Storm Grate/Utility Hazard?		N/A		N/A					
				N/A		Ramp inside XWalk1?		N/A		Storm Grate/Utility Type									
				N/A		Any Obstructions?		N/A						N/A					
						Obstruction Type				Yes		Surface Condition? (G/P)		Good					
								N/A		N/A		Curb Slope (%)		1.7					
				Total Cost:		\$		1600.00

Remove & Replace Entire Ramp.

R304.5.3

\$ 1600.00
