Access Compliance Report

Public Rights-of-Way

(Curb Ramps)

Intersection ID: 44063	Main Street: SEDGEMOOR_LN	Cross Street: GRAYWELL_LN	Location: W
ADA ID: D92F26B68048	Ramp Type: PerpDiag	Initial Pass/Fail: Fail	Overall Compliance: No
		Severity Score: 22.5

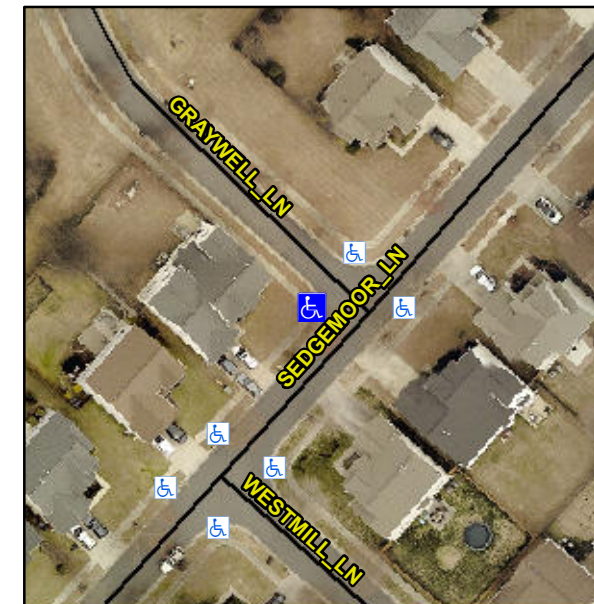
Compliance	Description	Data	Compliance	Description	Data
N/A	Ramp Length (in)	53.0	No	Ramp Slope (%)	8.5
No	Ramp Width (in)	36.0	No	Ramp XSlope (%)	2.8
N/A	Flare Type LT	N/A	N/A	Flare Type RT	N/A
N/A	Flare Slope LT (%)	N/A	N/A	Flare Slope RT (%)	N/A
N/A	Flare Traversable LT?	N/A	N/A	Flare Traversable RT?	N/A
N/A	Landing Length (in)	N/A	N/A	DWS Provided?	N/A
N/A	Landing Width (in)	N/A	N/A	DWS Contrast?	N/A
N/A	Landing Slope (%)	N/A	N/A	DWS Length (in)	N/A
N/A	Landing X Slope (%)	N/A	N/A	DWS Full Width?	N/A
N/A	Landing Curb? (Y/N)	N/A	N/A	DWS Offset (in)	N/A
N/A	Shared Landing?	N/A			
N/A	Gutter Ponding?	N/A	N/A	Gutter Slope (%)	N/A
N/A	Gutter Lip Ht (in)	N/A	N/A	Gutter X Slope (%)	N/A
N/A	Painted X Walk1?	No	N/A	Painted X Walk2?	No
	X Walk 1 Direction	To NE		X Walk 2 Direction	To SE
N/A	X Walk 1 Width (in)	N/A	N/A	X Walk 2 Width (in)	N/A
	X Walk 1 Slope (%)	4.8		X Walk 2 Slope (%)	2.2
	X Walk 1 X Slope (%)	1.4		X Walk 2 X Slope (%)	3.3

N/A	Ramp inside XWalk1?	N/A	N/A	Ramp inside XWalk2?	N/A
	Road Slope (%)	2.0	N/A	Clear Space?	N/A
	Road X Slope (%)	5.1	N/A	Clear Space to XWalk (in)	N/A
N/A	Any Obstructions?	N/A	N/A	Storm Grate/Utility Hazard?	N/A
	Obstruction Type			Storm Grate/Utility Type	
		N/A			N/A
			Yes	Surface Condition? (G/P)	Good

Remove & Replace Curb Ramp With Two New Directional Ramps or Equivalent.

R304.5.1, R304.2.2, R304.5.3
