Access Compliance Report

Public Rights-of-Way

(Curb Ramps)

Intersection ID: 13224	Main Street: BARRINGER_DR	Cross Street: BETHEL_RD	Location: W
ADA ID: D937B67B070C	Ramp Type: BlendTrans2	Initial Pass/Fail: Fail	Overall Compliance: No
			Severity Score: 33.75

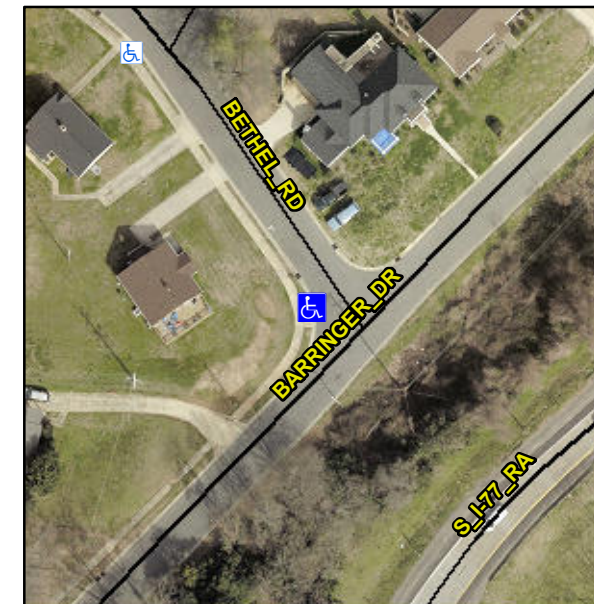
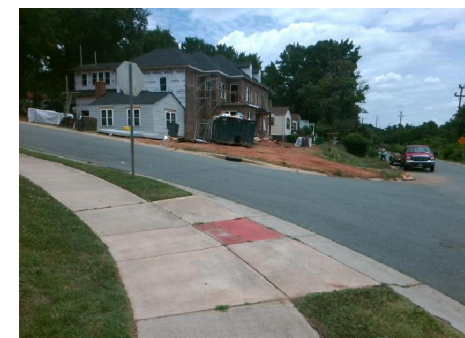
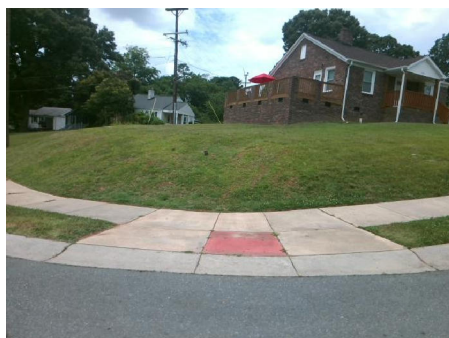
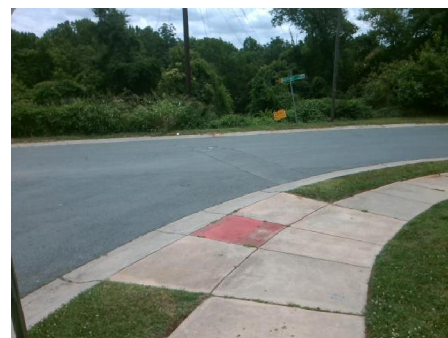
Not Found, R304.5.1, R304.5.3

Compliance	Description	Data	Compliance	Description	Data
N/A	Ramp Length (in)	107.0	Yes	BlendTrans Slope (%)	4.6
No	Ramp Width (in)	37.0	No	BlendTrans XSlope (%)	10.7
N/A	Flare Type LT	N/A	N/A	Flare Type RT	N/A
N/A	Flare Slope LT (%)	N/A	N/A	Flare Slope RT (%)	N/A
N/A	Flare Traversable LT?	N/A	N/A	Flare Traversable RT?	N/A
N/A	Landing Length (in)	N/A	N/A	DWS Provided?	N/A
N/A	Landing Width (in)	N/A	N/A	DWS Contrast?	N/A
N/A	Landing Slope (%)	N/A	N/A	DWS Length (in)	N/A
N/A	Landing X Slope (%)	N/A	N/A	DWS Full Width?	N/A
N/A	Landing Curb? (Y/N)	N/A	N/A	DWS Offset (in)	N/A
N/A	Shared Landing?	N/A			
N/A	Gutter Ponding?	N/A	N/A	Gutter Slope (%)	N/A
N/A	Gutter Lip Ht (in)	N/A	N/A	Gutter X Slope (%)	N/A
N/A	Painted X Walk1?	No	N/A	Painted X Walk2?	No
	X Walk 1 Direction	To SE		X Walk 2 Direction	To NE
	X Walk 1 Width (in)	N/A		X Walk 2 Width (in)	N/A
	X Walk 1 Slope (%)	6.0		X Walk 2 Slope (%)	2.2
	X Walk 1 X Slope (%)	2.5		X Walk 2 X Slope (%)	7.1

N/A	Ramp inside XWalk1?	N/A	N/A	Ramp inside XWalk2?	N/A
	Road Slope (%)	8.1		Clear Space?	N/A
	Road X Slope (%)	0.5	N/A	Clear Space to XWalk (in)	N/A
N/A	Any Obstructions?	N/A	N/A	Storm Grate/Utility Hazard?	N/A
	Obstruction Type			Storm Grate/Utility Type	
		N/A			N/A
			Yes	Surface Condition? (G/P)	Good
			No	Curb Slope (%)	10.5

Remove & Replace Curb Ramp With Two New Directional Ramps or Equivalent.
