Access Compliance Report Public Rights-of-Way (Curb Ramps)

Intersection ID: 25033 Main Street: ARBORETUM VIEW **Cross Street: PINEVILLE-MATTHEWS RD** Location: NW ADA ID: D94158375BA8 Ramp Type: PerpDiag Initial Pass/Fail: Fail **Overall Compliance: No Severity Score:** 37.5

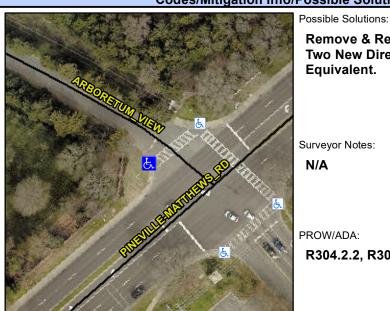
Comp	oliance Description	Data	Comp	liance Description	Data
N/A	Ramp Length (in)	60.0	No	Ramp Slope (%)	10.1
Yes	Ramp Width (in)	48.0	No	Ramp XSlope (%)	7.6
N/A	Flare Type LT	N/A	N/A	Flare Type RT	N/A
N/A	Flare Slope LT (%)	N/A	N/A	Flare Slope RT (%)	N/A
N/A	Flare Traversable LT?	N/A	N/A	Flare Traversable RT?	N/A
N/A	Landing Length (in)	N/A	N/A	DWS Provided?	N/A
N/A	Landing Width (in)	N/A	N/A	DWS Contrast?	N/A
N/A	Landing Slope (%)	N/A	N/A	DWS Length (in)	N/A
N/A	Landing X Slope (%)	N/A	N/A	DWS Full Width?	N/A
N/A	Landing Curb? (Y/N)	N/A	N/A	DWS Offset (in)	N/A
N/A	Shared Landing?	N/A			
N/A	Gutter Ponding?	N/A	N/A	Gutter Slope (%)	N/A
N/A	Gutter Lip Ht (in)	N/A	N/A	Gutter X Slope (%)	N/A
N/A	Painted X Walk1?	No	N/A	Painted X Walk2?	Yes
	X Walk 1 Direction	To SE		X Walk 2 Direction	To NE
N/A	X Walk 1 Width (in)	N/A	N/A	X Walk 2 Width (in)	111.0
	X Walk 1 Slope (%)	3.1		X Walk 2 Slope (%)	4.6
	X Walk 1 X Slope (%)	4.6		X Walk 2 X Slope (%)	3.6

N/A	Ramp inside XWalk1?	N/A	N/A	Ramp inside XWalk2?	Yes
	Road Slope (%)	7.0	N/A	Clear Space?	N/A
	Road X Slope (%)	2.0	N/A	Clear Space to XWalk (in)	N/A
N/A	Any Obstructions?	N/A	N/A	Storm Grate/Utility Hazard	? N/A
	Obstruction Type		l	Storm Grate/Utility Type	
			I

Remove & Replace Curb Ramp With **Two New Directional Ramps or** Equivalent.

R304.2.2, R304.5.3
