# Access Compliance Report

## Public Rights-of-Way

### (Curb Ramps)

Intersection ID: 8671	Main Street: BRADFORD_DR	Cross Street: SARATOGA_DR	Location: NW
ADA ID: D943F2D9C53E	Ramp Type: Directional2	Initial Pass/Fail: Fail	Overall Compliance: No
Severity Score: 13.75			
Codes/Mitigation Info/Possible Solution		Field Measurements/Component Compliance

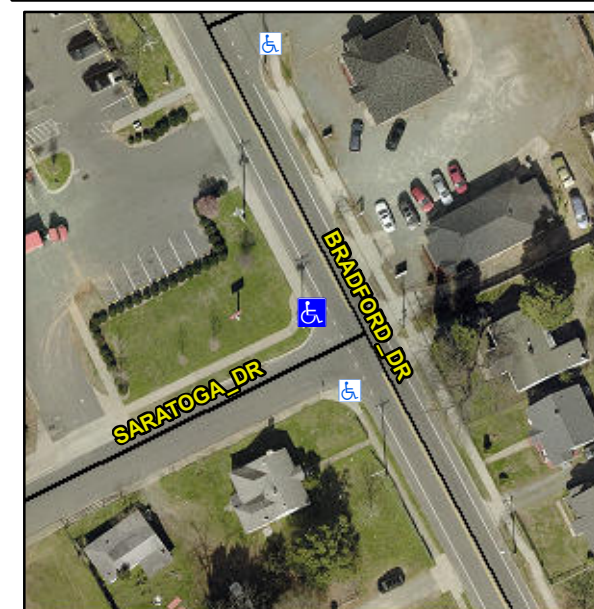
**R304.2.2, R304.5.3**

Compliance	Description	Data	Compliance	Description	Data
N/A	Ramp Length (in)	89.0	N/A	Grade Break?	N/A
Yes	Ramp Width (in)	48.0	N/A	Grade Break Slope (%)	0.0
No	Ramp Slope (%)	8.4	N/A	Grade Break XSlope (%)	0.0
No	Ramp XSlope (%)	2.8			
N/A	Flare Type LT	N/A	N/A	Flare Type RT	N/A
N/A	Flare Slope LT (%)	N/A	N/A	Flare Slope RT (%)	0.0
N/A	Flare Traversable LT?	N/A	N/A	Flare Traversable RT?	N/A
N/A	Landing Length (in)	0.0	N/A	DWS Provided?	N/A
N/A	Landing Width (in)	0.0	N/A	DWS Contrast?	N/A
N/A	Landing Slope (%)	0.0	N/A	DWS Length (in)	N/A
N/A	Landing X Slope (%)	0.0	N/A	DWS Full Width?	N/A
N/A	Landing Curb? (Y/N)	N/A	N/A	DWS Offset LT (in)	N/A
N/A	Shared Landing?	N/A	N/A	DWS Offset RT (in)	N/A
N/A	Gutter Ponding?	0.0	N/A	Gutter Slope (%)	N/A
N/A	Gutter Lip Ht (in)	0.0	N/A	Gutter X Slope (%)	N/A
N/A	Painted X Walk1?	No		Road Slope (%)	0.8
	X Walk 1 Direction	To S		Road X Slope (%)	0.3
	X Walk 1 Width (in)	N/A		Clear Space?	N/A

X Walk 1 Slope (%)	0.8	N/A	Clear Space to XWalk (in)	N/A
	X Walk 1 X Slope (%)	0.3	N/A	Storm Grate/Utility Hazard?	N/A
N/A	Ramp inside XWalk1?	N/A		Storm Grate/Utility Type	
N/A	Any Obstructions?	N/A			N/A
	Obstruction Type		Yes	Surface Condition? (G/P)	Good
			N/A	Curb Slope (%)	17.8

**Remove & Replace Entire Ramp.**
