# Access Compliance Report

## Public Rights-of-Way

### (Curb Ramps)

Intersection ID: 8895	Main Street: BINGHAM_DR	Cross Street: N_TRYON_ST	Location: SE
ADA ID: D94AB89BE41B	Ramp Type: Perp	Initial Pass/Fail: Fail	Overall Compliance: No
Severity Score: 25			
Codes/Mitigation Info/Possible Solution		Field Measurements/Component Compliance

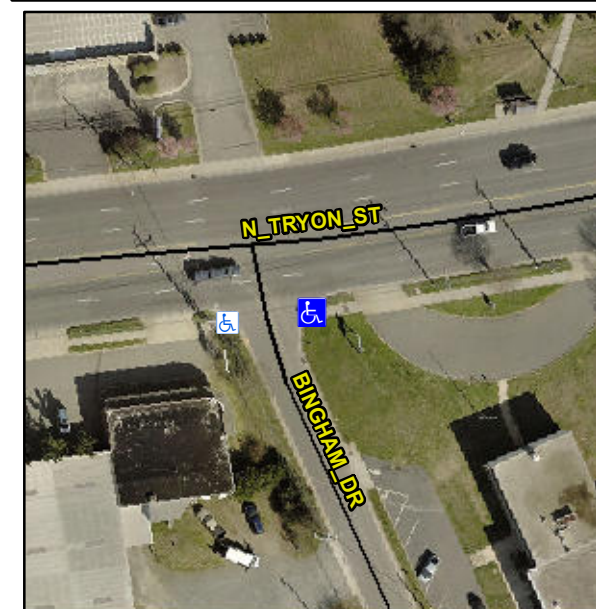
Compliance	Description	Data	Compliance	Description	Data
N/A	Ramp Length (in)	25.5	Yes	Ramp Slope (%)	5.2
Yes	Ramp Width (in)	48.0	No	Ramp XSlope (%)	9.0
N/A	Flare Type LT	N/A	N/A	Flare Type RT	N/A
N/A	Flare Slope LT (%)	N/A	N/A	Flare Slope RT (%)	N/A
N/A	Flare Traversable LT?	N/A	N/A	Flare Traversable RT?	N/A
N/A	Landing Length (in)	N/A	N/A	DWS Provided?	N/A
N/A	Landing Width (in)	N/A	N/A	DWS Contrast?	N/A
N/A	Landing Slope (%)	N/A	N/A	DWS Length (in)	N/A
N/A	Landing X Slope (%)	N/A	N/A	DWS Full Width?	N/A
N/A	Landing Curb? (Y/N)	N/A	N/A	DWS Offset (in)	N/A
N/A	Shared Landing?	N/A			
N/A	Gutter Ponding?	N/A	N/A	Gutter Slope (%)	N/A
N/A	Gutter Lip Ht (in)	N/A	N/A	Gutter X Slope (%)	N/A
N/A	Painted X Walk1?	No	N/A	Painted X Walk2?	N/A
	X Walk 1 Direction	To W		X Walk 2 Direction	N/A
N/A	X Walk 1 Width (in)	N/A	N/A	X Walk 2 Width (in)	N/A
	X Walk 1 Slope (%)	0.2		X Walk 2 Slope (%)	N/A
	X Walk 1 X Slope (%)	5.4		X Walk 2 X Slope (%)	N/A

N/A	Ramp inside XWalk1?	N/A	N/A	Ramp inside XWalk2?	N/A
	Road Slope (%)	N/A	N/A	Clear Space?	N/A
	Road X Slope (%)	N/A	N/A	Clear Space to XWalk (in)	N/A
N/A	Any Obstructions?	N/A	N/A	Storm Grate/Utility Hazard?	N/A
	Obstruction Type			Storm Grate/Utility Type	
		N/A			N/A
		Yes		Surface Condition? (G/P)	Good

Possible Solutions:

**Remove & Replace Entire Ramp.**

**Not Found, R304.5.3**

Total Cost: \$ 1850.00
