# Access Compliance Report

## Public Rights-of-Way

### (Curb Ramps)

Intersection ID: 31365	Main Street: KILEY_LN	Cross Street: MCINTYRE_RIDGE_DR	Location: SE
ADA ID: D94D07F7A963	Ramp Type: Combination1Diag	Initial Pass/Fail: Fail	Overall Compliance: No
		Severity Score: 0

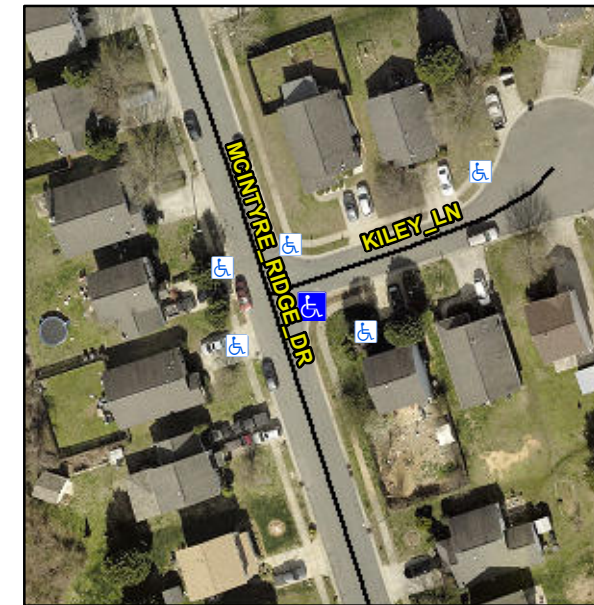
**RT RP < 5%**

**R304.5.1, R304.5.1, R304.5.3**

Compliance	Description	Data	Compliance	Description	Data
N/A	Ramp Length LT (in)	54.0	N/A	Ramp Length RT (in)	45.0
Yes	Ramp Width LT (in)	49.5	No	Ramp Width RT (in)	47.5
Yes	Ramp Slope LT (%)	6.4	Yes	Ramp Slope RT (%)	2.3
Yes	Ramp XSlope LT (%)	1.6	No	Ramp XSlope RT (%)	2.8
N/A	Ramp Length (in)	47.0	Yes	Ramp Slope (%)	5.1
No	Ramp Width (in)	39.5	No	Ramp XSlope (%)	2.5
N/A	Flare Type LT	N/A	N/A	Flare Type RT	N/A
N/A	Flare Slope LT (%)	N/A	N/A	Flare Slope RT (%)	N/A
N/A	Flare Traversable LT?	N/A	N/A	Flare Traversable RT?	N/A
N/A	Landing Length (in)	N/A	N/A	DWS Provided?	N/A
N/A	Landing Width (in)	N/A	N/A	DWS Contrast?	N/A
N/A	Landing Slope (%)	N/A	N/A	DWS Length (in)	N/A
N/A	Landing X Slope (%)	N/A	N/A	DWS Full Width?	N/A
N/A	Landing Curb? (Y/N)	N/A	N/A	DWS Offset (in)	N/A
N/A	Shared Landing?	N/A			
N/A	Gutter Ponding?	N/A	N/A	Gutter Slope (%)	N/A
N/A	Gutter Lip Ht (in)	N/A	N/A	Gutter X Slope (%)	N/A
N/A	Painted X Walk1?	No	N/A	Painted X Walk2?	No

**Remove & Replace Curb Ramp With Two New Directional Ramps or Equivalent.**

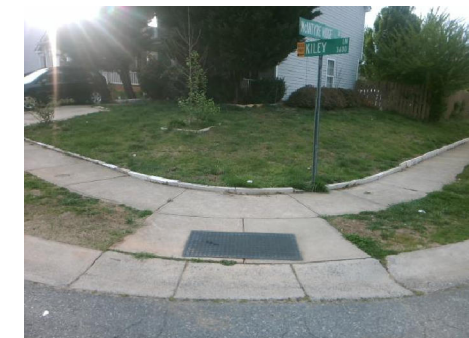
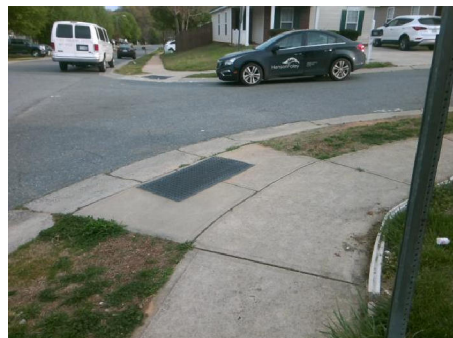
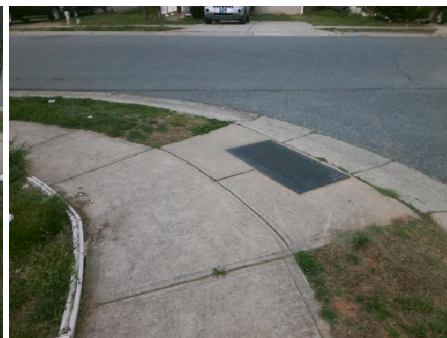
X Walk 1 Direction	To N		X Walk 2 Direction	To W
	X Walk 1 Width (in)	N/A		X Walk 2 Width (in)	N/A
	X Walk 1 Slope (%)	3.2		X Walk 2 Slope (%)	0.7
	X Walk 1 X Slope (%)	1.1		X Walk 2 X Slope (%)	2.1
N/A	Ramp inside XWalk1?	N/A	N/A	Ramp inside XWalk2?	N/A
	Road Slope (%)	1.9		Clear Space?	N/A
	Road X Slope (%)	0.2	N/A	Clear Space to XWalk (in)	N/A
			N/A	Any Obstruction?	N/A
				Obstruction Type	N/A
			N/A	Storm Grate/Utility Hazard?	N/A
				Storm Grate/Utility Type	N/A
Yes	Surface Condition? (G/P)	Good			
	Curb Slope (%)	N/A
