# Access Compliance Report

## Public Rights-of-Way

### (Curb Ramps)

| Intersection ID: 29681 | Main Street: DARLINGTON_RD | Cross Street: EQUESTRIAN_DR | Location: S |

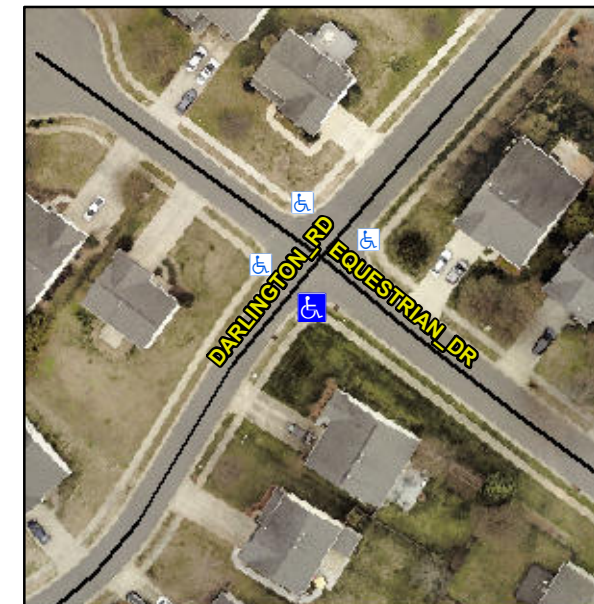
| ADA ID: D94F3A50B1A6 | Ramp Type: PerpDiag | Initial Pass/Fail: Fail | Overall Compliance: No |
| | | Severity Score: 22.5 | |

**Not Found, R304.5.1, R304.2.2, R304.5.3**

| Compliance | Description | Data | Compliance | Description | Data |
|---|---|---|---|---|---|
| N/A | Ramp Length (in) | 50.0 | No | Ramp Slope (%) | 9.2 |
| No | Ramp Width (in) | 42.0 | No | Ramp XSlope (%) | 2.9 |

**Remove & Replace Curb Ramp With Two New Directional Ramps or Equivalent.**

Total Cost: \$ 3200.00
