# Access Compliance Report

## Public Rights-of-Way

### (Curb Ramps)

| Intersection ID: 14757 | Main Street: E_WORTHINGTON_AV | Cross Street: LENNOX_AV | Location: W |

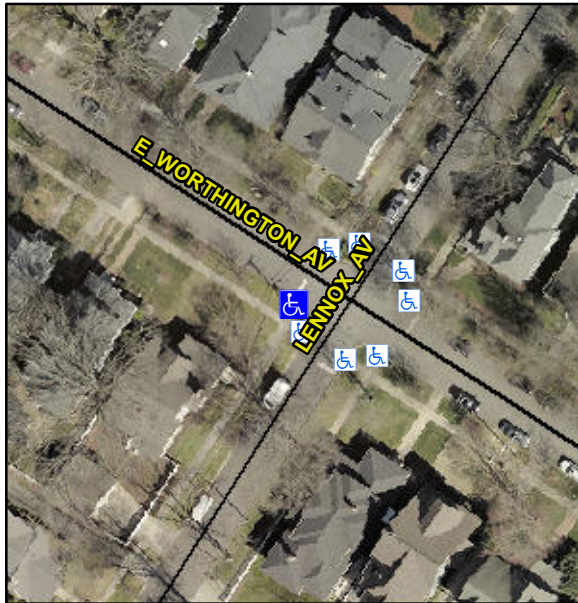
| Severity Score: 17.5 | | | |

**Not Found, R305.1.4, R302.7.2**

| Compliance | Description | Data | Compliance | Description | Data |
|---|---|---|---|---|---|
| Yes | Landing X Slope (%) | 1.4 | No | DWS Full Width? | No |
| No | Gutter Lip Ht (in) | 2.0 | Yes | Gutter X Slope (%) | 1.4 |

**Remove & Replace Entire Ramp.**

Total Cost: \$ **1850.00**
