## **Access Compliance Report Public Rights-of-Way** (Curb Ramps)

Intersection ID: 53191 Main Street: JOHNSTON\_OEHLER\_PRIVATECEDS Street: JOHNSTON\_OEHLER\_RD Location: ADA ID: D973321335AB Ramp Type: Perp Initial Pass/Fail: Fail **Overall Compliance: No Severity Score:** 12.5

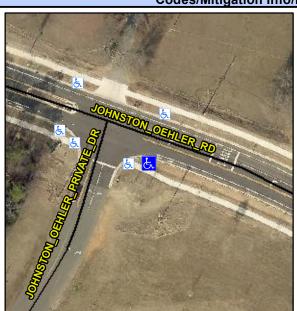
Field Measurements/Component Compliance						
	Compliance Description		Data	Compliance Description		Data
	N/A	Ramp Length (in)	100.0	No	Ramp Slope (%)	10.7
	Yes	Ramp Width (in)	94.0	Yes	Ramp XSlope (%)	1.6
	N/A	Flare Type LT	N/A	N/A	Flare Type RT	N/A
	N/A	Flare Slope LT (%)	N/A	N/A	Flare Slope RT (%)	N/A
	N/A	Flare Traversable LT?	N/A	N/A	Flare Traversable RT?	N/A
	N/A	Landing Length (in)	N/A	N/A	DWS Provided?	N/A
	N/A	Landing Width (in)	N/A	N/A	DWS Contrast?	N/A
	N/A	Landing Slope (%)	N/A	N/A	DWS Length (in)	N/A
	N/A	Landing X Slope (%)	N/A	N/A	DWS Full Width?	N/A
	N/A	Landing Curb? (Y/N)	N/A	N/A	DWS Offset (in)	N/A
	N/A	Shared Landing?	N/A			
	N/A	Gutter Ponding?	N/A	N/A	Gutter Slope (%)	N/A
	N/A	Gutter Lip Ht (in)	N/A	N/A	Gutter X Slope (%)	N/A
	N/A	Painted X Walk1?	No	N/A	Painted X Walk2?	N/A
		X Walk 1 Direction	To NE		X Walk 2 Direction	N/A
	N/A	X Walk 1 Width (in)	N/A	N/A	X Walk 2 Width (in)	N/A
		X Walk 1 Slope (%)	2.6		X Walk 2 Slope (%)	N/A

Possible Solutions: Remove & Replace Entire Ramp. Surveyor Notes: N/A PROW/ADA: R304.2.2
