# Access Compliance Report

## Public Rights-of-Way

### (Curb Ramps)

Intersection ID: 28674	Main Street: ARBORHILL_RD	Cross Street: WINTHROP_RIDGE_RD	Location: NW
ADA ID: D9757E5DC479	Ramp Type: BlendTrans1	Initial Pass/Fail: Fail	Overall Compliance: No
		Severity Score: 10

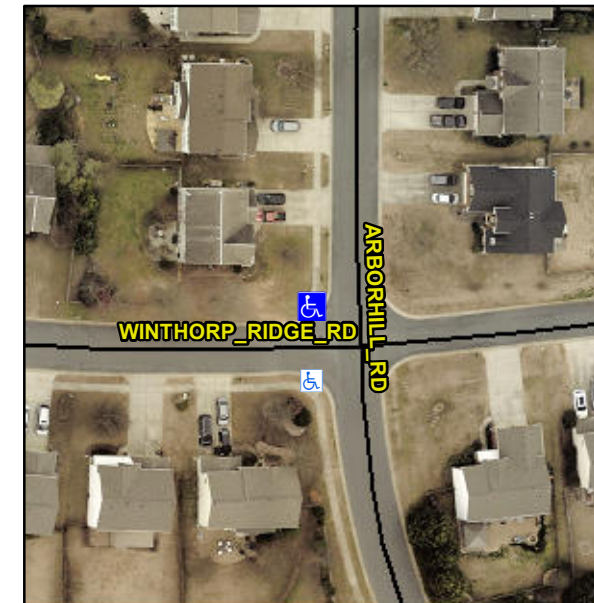
**Not Found, R304.5.1, R304.5.3**

Compliance	Description	Data	Compliance	Description	Data
N/A	Ramp Length (in)	49.0	Yes	BlendTrans Slope (%)	4.2
No	Ramp Width (in)	39.0	No	BlendTrans XSlope (%)	4.4
N/A	Flare Type LT	N/A	N/A	Flare Type RT	N/A
N/A	Flare Slope LT (%)	N/A	N/A	Flare Slope RT (%)	N/A
N/A	Flare Traversable LT?	N/A	N/A	Flare Traversable RT?	N/A
N/A	Landing Length (in)	N/A	N/A	DWS Provided?	N/A
N/A	Landing Width (in)	N/A	N/A	DWS Contrast?	N/A
N/A	Landing Slope (%)	N/A	N/A	DWS Length (in)	N/A
N/A	Landing X Slope (%)	N/A	N/A	DWS Full Width?	N/A
N/A	Landing Curb? (Y/N)	N/A	N/A	DWS Offset (in)	N/A
N/A	Shared Landing?	N/A			
N/A	Gutter Ponding?	N/A	N/A	Gutter Slope (%)	N/A
N/A	Gutter Lip Ht (in)	N/A	N/A	Gutter X Slope (%)	N/A
N/A	Painted X Walk1?	No	N/A	Painted X Walk2?	N/A
	X Walk 1 Direction	To S		X Walk 2 Direction	N/A
	X Walk 1 Width (in)	N/A		X Walk 2 Width (in)	N/A
	X Walk 1 Slope (%)	2.4		X Walk 2 Slope (%)	N/A
	X Walk 1 X Slope (%)	3.6		X Walk 2 X Slope (%)	N/A

N/A	Ramp inside XWalk1?	N/A	N/A	Ramp inside XWalk2?	N/A
	Road Slope (%)	3.6		Clear Space?	N/A
	Road X Slope (%)	2.4	N/A	Clear Space to XWalk (in)	N/A
N/A	Any Obstructions?	N/A	N/A	Storm Grate/Utility Hazard?	N/A
	Obstruction Type			Storm Grate/Utility Type	
		N/A			N/A
			Yes	Surface Condition? (G/P)	Good
			No	Curb Slope (%)	14.9

**Remove & Replace Curb Ramp With Two New Directional Ramps or Equivalent.**
