Access Compliance Report

Public Rights-of-Way

(Curb Ramps)

Intersection ID: 47909	Main Street: MOUNTAIN_QUAIL_DR	Cross Street: HARRIER_RD	Location: W
ADA ID: D986D9048946	Ramp Type: PerpDiag	Initial Pass/Fail: Fail	Overall Compliance: No
Severity Score: 31.25			
Codes/Mitigation Info/Possible Solution		Field Measurements/Component Compliance

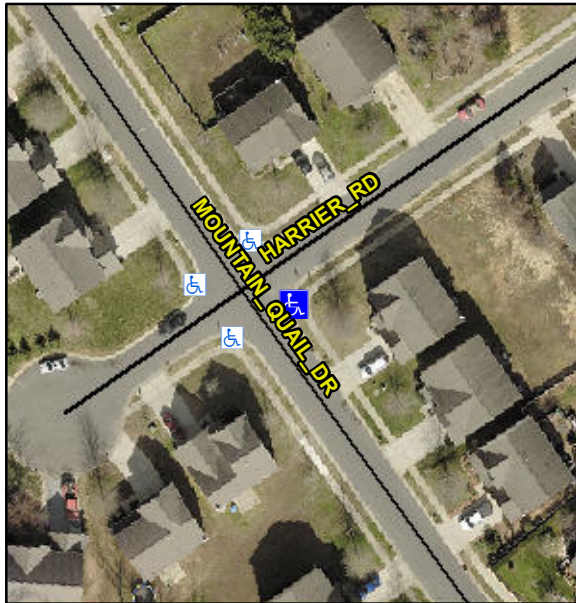
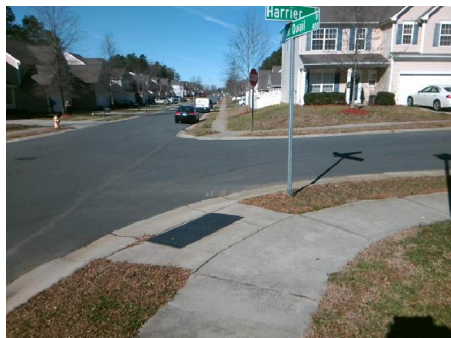
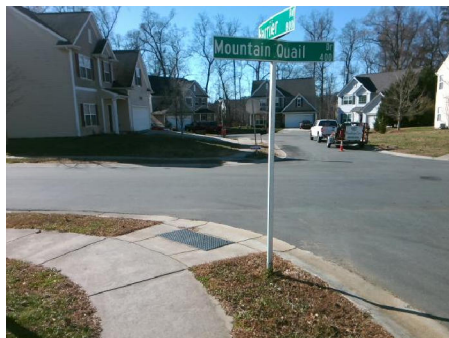
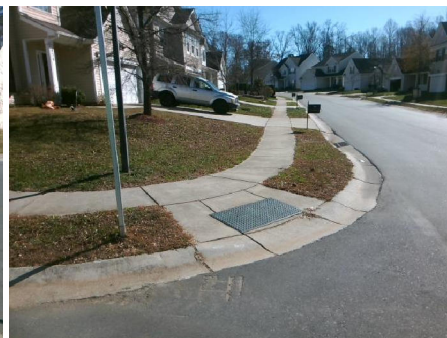
Not Found, R304.5.1, R304.2.2, R304.5.3

Compliance	Description	Data	Compliance	Description	Data
N/A	Ramp Length (in)	48.0	No	Ramp Slope (%)	11.9
No	Ramp Width (in)	35.0	No	Ramp XSlope (%)	2.6
N/A	Flare Type LT	N/A	N/A	Flare Type RT	N/A
N/A	Flare Slope LT (%)	N/A	N/A	Flare Slope RT (%)	N/A
N/A	Flare Traversable LT?	N/A	N/A	Flare Traversable RT?	N/A
N/A	Landing Length (in)	N/A	N/A	DWS Provided?	N/A
N/A	Landing Width (in)	N/A	N/A	DWS Contrast?	N/A
N/A	Landing Slope (%)	N/A	N/A	DWS Length (in)	N/A
N/A	Landing X Slope (%)	N/A	N/A	DWS Full Width?	N/A
N/A	Landing Curb? (Y/N)	N/A	N/A	DWS Offset (in)	N/A
N/A	Shared Landing?	N/A			
N/A	Gutter Ponding?	N/A	N/A	Gutter Slope (%)	N/A
N/A	Gutter Lip Ht (in)	N/A	N/A	Gutter X Slope (%)	N/A
N/A	Painted X Walk1?	No	N/A	Painted X Walk2?	No
	X Walk 1 Direction	To NE		X Walk 2 Direction	To SE
N/A	X Walk 1 Width (in)	N/A	N/A	X Walk 2 Width (in)	N/A
	X Walk 1 Slope (%)	2.6		X Walk 2 Slope (%)	0.6
	X Walk 1 X Slope (%)	4.2		X Walk 2 X Slope (%)	2.1

N/A	Ramp inside XWalk1?	N/A	N/A	Ramp inside XWalk2?	N/A
	Road Slope (%)	3.2	N/A	Clear Space?	N/A
	Road X Slope (%)	5.7	N/A	Clear Space to XWalk (in)	N/A
N/A	Any Obstructions?	N/A	N/A	Storm Grate/Utility Hazard?	N/A
	Obstruction Type			Storm Grate/Utility Type	
		N/A			N/A
			Yes	Surface Condition? (G/P)	Good

Remove & Replace Curb Ramp With Two New Directional Ramps or Equivalent.
