Access Compliance Report

Public Rights-of-Way

(Curb Ramps)

Intersection ID: 9847	Main Street: BLACKWOOD_AV	Cross Street: THE_PLAZA	Location: SE
ADA ID: D98AA87639D4	Ramp Type: Perp	Initial Pass/Fail: Fail	Overall Compliance: No
		Severity Score: 10

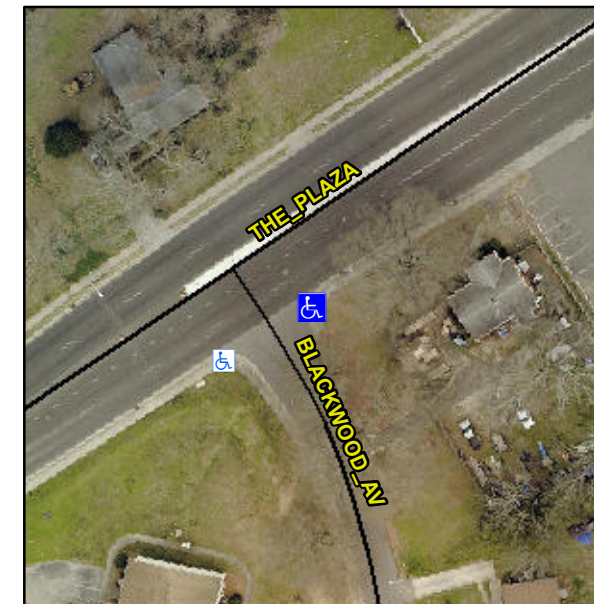
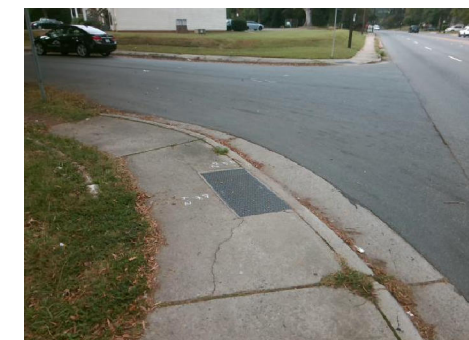
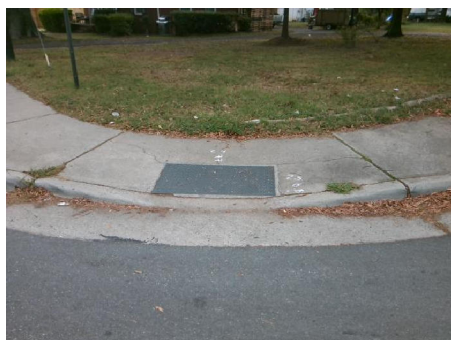
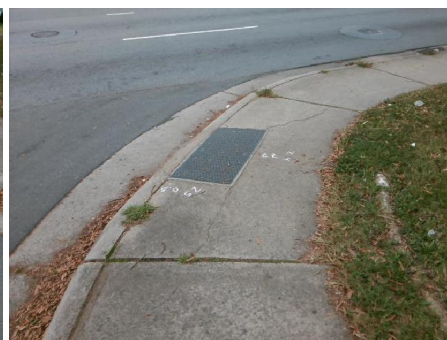
Not Found, R304.5.1, R304.5.3

Compliance	Description	Data	Compliance	Description	Data
N/A	Ramp Length (in)	60.0	Yes	Ramp Slope (%)	7.7
No	Ramp Width (in)	44.0	No	Ramp XSlope (%)	2.4
N/A	Flare Type LT	N/A	N/A	Flare Type RT	N/A
N/A	Flare Slope LT (%)	N/A	N/A	Flare Slope RT (%)	N/A
N/A	Flare Traversable LT?	N/A	N/A	Flare Traversable RT?	N/A
N/A	Landing Length (in)	N/A	N/A	DWS Provided?	N/A
N/A	Landing Width (in)	N/A	N/A	DWS Contrast?	N/A
N/A	Landing Slope (%)	N/A	N/A	DWS Length (in)	N/A
N/A	Landing X Slope (%)	N/A	N/A	DWS Full Width?	N/A
N/A	Landing Curb? (Y/N)	N/A	N/A	DWS Offset (in)	N/A
N/A	Shared Landing?	N/A			
N/A	Gutter Ponding?	N/A	N/A	Gutter Slope (%)	N/A
N/A	Gutter Lip Ht (in)	N/A	N/A	Gutter X Slope (%)	N/A
N/A	Painted X Walk1?	No	N/A	Painted X Walk2?	N/A
	X Walk 1 Direction	To SW		X Walk 2 Direction	N/A
N/A	X Walk 1 Width (in)	N/A	N/A	X Walk 2 Width (in)	N/A
	X Walk 1 Slope (%)	0.8		X Walk 2 Slope (%)	N/A
	X Walk 1 X Slope (%)	2.5		X Walk 2 X Slope (%)	N/A

N/A	Ramp inside XWalk1?	N/A	N/A	Ramp inside XWalk2?	N/A
	Road Slope (%)	N/A	N/A	Clear Space?	N/A
	Road X Slope (%)	N/A	N/A	Clear Space to XWalk (in)	N/A
N/A	Any Obstructions?	N/A	N/A	Storm Grate/Utility Hazard?	N/A
	Obstruction Type			Storm Grate/Utility Type	
		N/A			N/A
			Yes	Surface Condition? (G/P)	Good

Remove & Replace Entire Ramp.
