# Access Compliance Report

## Public Rights-of-Way

| Intersection ID: 11164 | Main Street: CAMP_GREENE_ST | Cross Street: FREEDOM_DR | Location: S |
| ADA ID: D98EDDC591F2 | Ramp Type: Perp | Initial Pass/Fail: Fail | Overall Compliance: No |

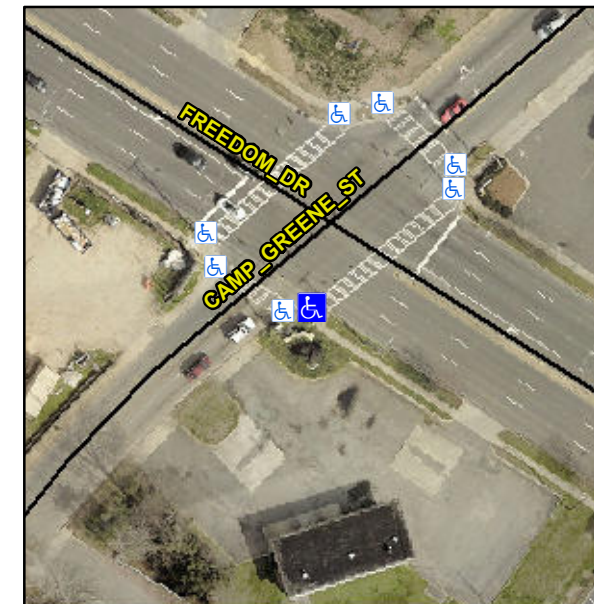
**R304.5.1**

| Compliance | Description | Data | Compliance | Description | Data |
|---|---|---|---|---|---|
| No | Ramp Width (in) | 47.0 | Yes | Ramp XSlope (%) | 0.3 |
| N/A | Gutter Ponding? | Yes | N/A | Gutter Slope (%) | N/A |

**Remove & Replace Entire Ramp.**

Total Cost: \$ 1850.00
