Access Compliance Report Public Rights-of-Way (Curb Ramps)

Intersection ID: 45063 Main Street: ESCAFLOWNE_AV Cross Street: REDDING_GLEN_AV Location: SW

ADA ID: D991A2A3DAFD Ramp Type: BlendTrans1 Initial Pass/Fail: Fail Overall Compliance: No Severity Score: 25

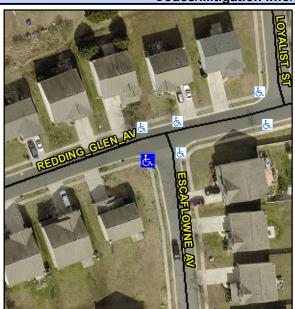
Compliance Description Data Compliance Description Data					
N/A	Ramp Length (in)	48.0	Yes	BlendTrans Slope (%)	4.3
Yes	,	48.0	No	1 ()	4.3 7.0
	Ramp Width (in)	46.0 N/A		BlendTrans XSlope (%)	
N/A	Flare Type LT		N/A	Flare Type RT	N/A
N/A	Flare Slope LT (%)	N/A	N/A	Flare Slope RT (%)	N/A
N/A	Flare Traversable LT?	N/A	N/A	Flare Traversable RT?	N/A
N/A	Landing Length (in)	N/A	N/A	DWS Provided?	N/A
N/A	Landing Width (in)	N/A	N/A	DWS Contrast?	N/A
N/A	Landing Slope (%)	N/A	N/A	DWS Length (in)	N/A
N/A	Landing X Slope (%)	N/A	N/A	DWS Full Width?	N/A
N/A	Landing Curb? (Y/N)	N/A	N/A	DWS Offset (in)	N/A
N/A	Shared Landing?	N/A			
N/A	Gutter Ponding?	N/A	N/A	Gutter Slope (%)	N/A
N/A	Gutter Lip Ht (in)	N/A	N/A	Gutter X Slope (%)	N/A
N/A	Painted X Walk1?	No	N/A	Painted X Walk2?	No
	X Walk 1 Direction	To E		X Walk 2 Direction	To N
	X Walk 1 Width (in)	N/A		X Walk 2 Width (in)	N/A
	X Walk 1 Slope (%)	2.2		X Walk 2 Slope (%)	0.9

X Walk 1 X Slope (%)	0.1		X Walk 2 X Slope (%)	4.6
N/A	Ramp inside XWalk1?	N/A	N/A	Ramp inside XWalk2?	N/A
	Road Slope (%)	4.5		Clear Space?	N/A
	Road X Slope (%)	3.8	N/A	Clear Space to XWalk (in)	N/A
N/A	Any Obstructions?	N/A	N/A	Storm Grate/Utility Hazard?	N/A
	Obstruction Type			Storm Grate/Utility Type	
		N/A			N/A
			Yes	Surface Condition? (G/P)	Good
			No	Curb Slope (%)	14.0

Remove & Replace Curb Ramp With Two New Directional Ramps or Equivalent.
