Access Compliance Report

Public Rights-of-Way

(Curb Ramps)

Intersection ID: 13916	Main Street: CLANTON_RD	Cross Street: WEST_BV	Location: SW
ADA ID: D99D357A9D3E	Ramp Type: Perp	Initial Pass/Fail: Fail	Overall Compliance: No
			Severity Score: 13.75

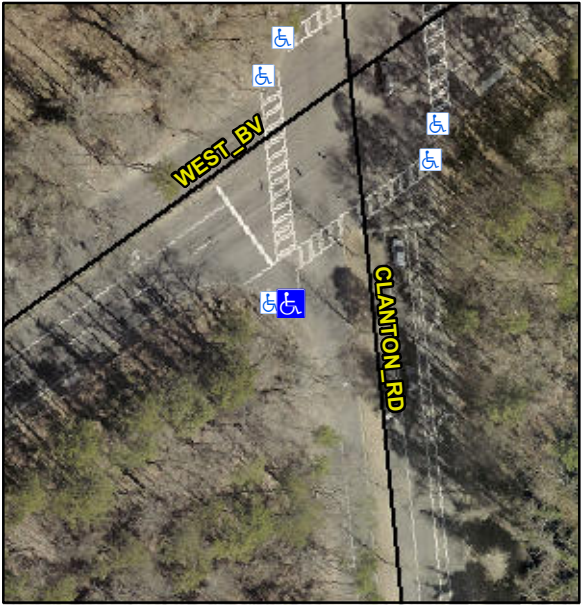
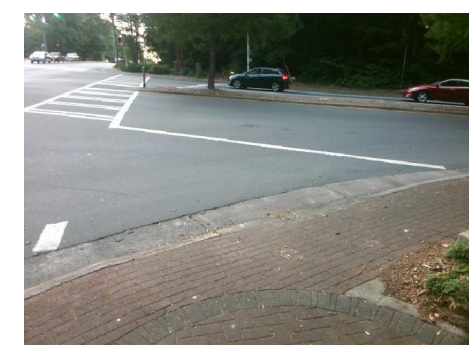
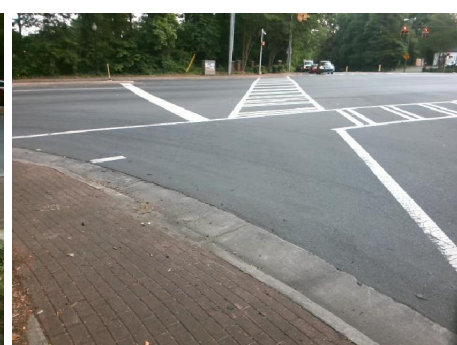
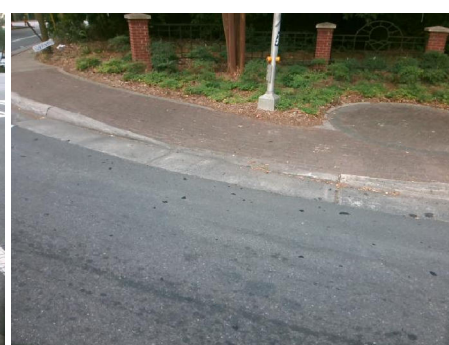
Possible Solutions:		Compliance	Description	Data
	Remove & Replace Entire Ramp.		No	Ramp Length (in)	60.0
	Restripe Crosswalk.		No	Ramp Width (in)	60.0
			N/A	Flare Type LT	N/A
			N/A	Flare Slope LT (%)	N/A
			N/A	Flare Traversable LT?	N/A
			N/A	Landing Length (in)	N/A
			N/A	Landing Width (in)	N/A
			N/A	Landing Slope (%)	N/A
			N/A	Landing X Slope (%)	N/A
<p>Surveyor Notes:</p> <p>N/A</p>			N/A	Flare Type RT	N/A
			N/A	Flare Slope RT (%)	N/A
			N/A	Flare Traversable RT?	N/A
			N/A	DWS Provided?	N/A
			N/A	DWS Contrast?	N/A
			N/A	DWS Length (in)	N/A
			N/A	DWS Full Width?	N/A
			N/A	DWS Offset (in)	N/A
			N/A	Shared Landing?	N/A
			N/A	Gutter Ponding?	N/A
<p>PROW/ADA:</p> <p>Not Found, R304.2.2, R304.5.3</p>			N/A	Gutter Lip Ht (in)	N/A
			N/A	Painted X Walk1?	Yes
				X Walk 1 Direction	To NE
			N/A	X Walk 1 Width (in)	104.0

X Walk 1 Slope (%)	5.6
				X Walk 1 X Slope (%)	1.1
			N/A	Ramp inside XWalk1?	No
			N/A	Road Slope (%)	N/A
			N/A	Road X Slope (%)	N/A
			N/A	Any Obstructions?	N/A
<p>Total Cost:</p> <p>\$ 2050.00</p>				Obstruction Type	
			N/A		
			N/A		
			N/A		
			N/A		
			N/A		
			N/A		
			N/A		
			N/A		
			N/A		
<p>Street 1 Name</p> <p>CLANTON RD</p>			Yes	Surface Condition? (G/P)	Good
<p>Stop Condition-Street 2</p> <p>Signal</p>					
<p>Street 2 Name</p> <p>N/A</p>					
<p>Stop Condition-Street 1</p> <p>N/A</p>
