Access Compliance Report

Public Rights-of-Way

(Curb Ramps)

Intersection ID: 10470	Main Street: MILTON_RD	Cross Street: PERTH_CT	Location: SE
ADA ID: D9C1F2100969	Ramp Type: PerpDiag	Initial Pass/Fail: Fail	Overall Compliance: No
Severity Score: 22.5			
Codes/Mitigation Info/Possible Solution		Field Measurements/Component Compliance

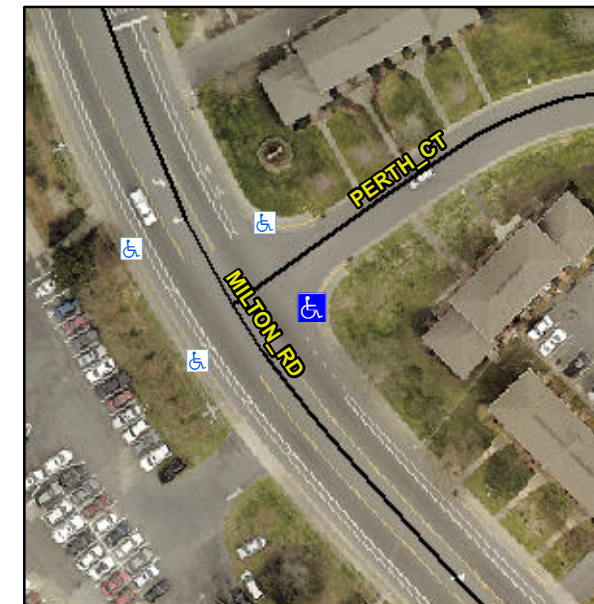
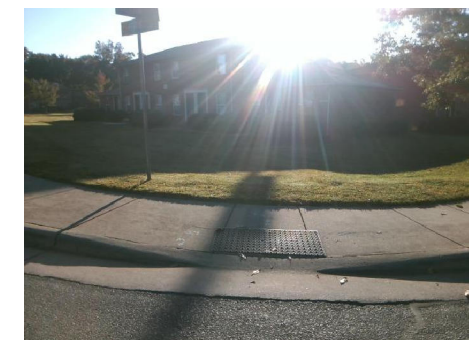
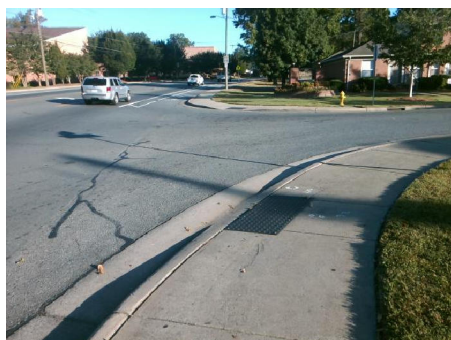
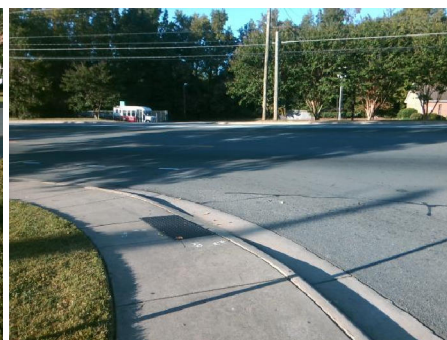
Not Found, R304.5.1, R304.2.2, R304.5.3

Compliance	Description	Data	Compliance	Description	Data
N/A	Ramp Length (in)	59.5	No	Ramp Slope (%)	9.0
No	Ramp Width (in)	37.0	No	Ramp XSlope (%)	2.6
N/A	Flare Type LT	N/A	N/A	Flare Type RT	N/A
N/A	Flare Slope LT (%)	N/A	N/A	Flare Slope RT (%)	N/A
N/A	Flare Traversable LT?	N/A	N/A	Flare Traversable RT?	N/A
N/A	Landing Length (in)	N/A	N/A	DWS Provided?	N/A
N/A	Landing Width (in)	N/A	N/A	DWS Contrast?	N/A
N/A	Landing Slope (%)	N/A	N/A	DWS Length (in)	N/A
N/A	Landing X Slope (%)	N/A	N/A	DWS Full Width?	N/A
N/A	Landing Curb? (Y/N)	N/A	N/A	DWS Offset (in)	N/A
N/A	Shared Landing?	N/A			
N/A	Gutter Ponding?	N/A	N/A	Gutter Slope (%)	N/A
N/A	Gutter Lip Ht (in)	0.5	N/A	Gutter X Slope (%)	N/A
N/A	Painted X Walk1?	No	N/A	Painted X Walk2?	No
	X Walk 1 Direction	To NW		X Walk 2 Direction	To SW
N/A	X Walk 1 Width (in)	N/A	N/A	X Walk 2 Width (in)	N/A
	X Walk 1 Slope (%)	2.3		X Walk 2 Slope (%)	2.9
	X Walk 1 X Slope (%)	0.4		X Walk 2 X Slope (%)	2.7

N/A	Ramp inside XWalk1?	N/A	N/A	Ramp inside XWalk2?	N/A
	Road Slope (%)	2.1	N/A	Clear Space?	N/A
	Road X Slope (%)	3.3	N/A	Clear Space to XWalk (in)	N/A
N/A	Any Obstructions?	N/A	N/A	Storm Grate/Utility Hazard?	N/A
	Obstruction Type			Storm Grate/Utility Type	
		N/A			N/A
			Yes	Surface Condition? (G/P)	Good

Remove & Replace Curb Ramp With Two New Directional Ramps or Equivalent.
