Access Compliance Report

Public Rights-of-Way

(Curb Ramps)

Intersection ID: 11748	Main Street: BERRYHILL_RD	Cross Street: FLEETWOOD_DR	Location:	W
ADA ID: D9C547432E59	Ramp Type: Perp	Initial Pass/Fail: Fail	Overall Compliance: No	Severity Score: 25
Codes/Mitigation Info/Possible Solution		Field Measurements/Component Compliance

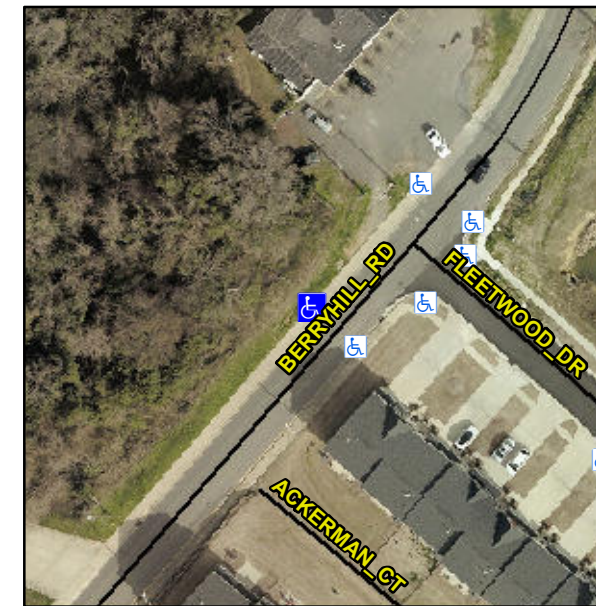
Not Found, R304.2.2, R304.5.3

Compliance	Description	Data	Compliance	Description	Data
N/A	Ramp Length (in)	59.0	No	Ramp Slope (%)	9.5
Yes	Ramp Width (in)	50.0	No	Ramp XSlope (%)	5.2
N/A	Flare Type LT	N/A	N/A	Flare Type RT	N/A
N/A	Flare Slope LT (%)	N/A	N/A	Flare Slope RT (%)	N/A
N/A	Flare Traversable LT?	N/A	N/A	Flare Traversable RT?	N/A
N/A	Landing Length (in)	N/A	N/A	DWS Provided?	N/A
N/A	Landing Width (in)	N/A	N/A	DWS Contrast?	N/A
N/A	Landing Slope (%)	N/A	N/A	DWS Length (in)	N/A
N/A	Landing X Slope (%)	N/A	N/A	DWS Full Width?	N/A
N/A	Landing Curb? (Y/N)	N/A	N/A	DWS Offset (in)	N/A
N/A	Shared Landing?	N/A			
N/A	Gutter Ponding?	N/A	N/A	Gutter Slope (%)	N/A
N/A	Gutter Lip Ht (in)	N/A	N/A	Gutter X Slope (%)	N/A
N/A	Painted X Walk1?	No	N/A	Painted X Walk2?	N/A
	X Walk 1 Direction	To SE		X Walk 2 Direction	N/A
N/A	X Walk 1 Width (in)	N/A	N/A	X Walk 2 Width (in)	N/A
	X Walk 1 Slope (%)	3.1		X Walk 2 Slope (%)	N/A
	X Walk 1 X Slope (%)	6.0		X Walk 2 X Slope (%)	N/A

N/A	Ramp inside XWalk1?	N/A	N/A	Ramp inside XWalk2?	N/A
	Road Slope (%)	N/A	N/A	Clear Space?	N/A
	Road X Slope (%)	N/A	N/A	Clear Space to XWalk (in)	N/A
N/A	Any Obstructions?	N/A	N/A	Storm Grate/Utility Hazard?	N/A
	Obstruction Type			Storm Grate/Utility Type	
		N/A			N/A
			Yes	Surface Condition? (G/P)	Good

Possible Solutions:

Remove & Replace Entire Ramp.
