## Access Compliance Report Public Rights-of-Way (Curb Ramps)

Intersection ID: 20942 Main Street: CORONATION\_BV Cross Street: CROWN CENTRE\_DR Location: SE

ADA ID: D9EC1518DB15 Ramp Type: PerpDiag Initial Pass/Fail: Fail Overall Compliance: No Severity Score: 12.5

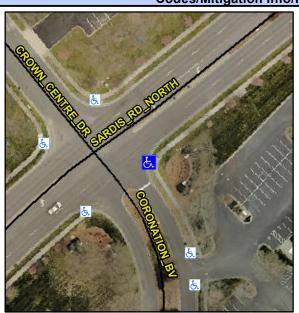
Compliance Description		Data	Compliance		Description	Data
N/A	Ramp Length (in)	72.0	No	Ramp	Slope (%)	11.7
Yes	Ramp Width (in)	48.0	Yes	Ramp	XSlope (%)	1.5
N/A	Flare Type LT	N/A	N/A	Flare T	Type RT	N/A
N/A	Flare Slope LT (%)	N/A	N/A	Flare S	Slope RT (%)	N/A
N/A	Flare Traversable LT?	N/A	N/A	Flare T	Traversable RT?	N/A
N/A	Landing Length (in)	N/A	N/A	DWS F	Provided?	N/A
N/A	Landing Width (in)	N/A	N/A	DWS (	Contrast?	N/A
N/A	Landing Slope (%)	N/A	N/A	DWS L	_ength (in)	N/A
N/A	Landing X Slope (%)	N/A	N/A	DWS F	Full Width?	N/A
N/A	Landing Curb? (Y/N)	N/A	N/A	DWS (	Offset (in)	N/A
N/A	Shared Landing?	N/A				
N/A	Gutter Ponding?	N/A	N/A	Gutter	Slope (%)	N/A
N/A	Gutter Lip Ht (in)	N/A	N/A	Gutter	X Slope (%)	N/A
N/A	Painted X Walk1?	No	N/A	Painte	d X Walk2?	No
	X Walk 1 Direction	To NW		X Walk	c 2 Direction	To SW
N/A	X Walk 1 Width (in)	N/A	N/A	X Walk	c 2 Width (in)	N/A
	X Walk 1 Slope (%)	3.0		X Walk	( 2 Slope (%)	5.1

X Walk 1 X Slope (%)	6.8		X Walk	( 2 X Slope (%)	2.0
N/A	Ramp inside XWalk1?	N/A	N/A	Ramp	inside XWalk2?	N/A
	Road Slope (%)	3.0	N/A	Clear S	Space?	N/A
	Road X Slope (%)	7.6	N/A	Clear S	Space to XWalk (in)	N/A
N/A	Any Obstructions?	N/A	N/A	Storm	Grate/Utility Hazard?	N/A
	Obstruction Type		l	Storm	Grate/Utility Type	
		N/A	l			N/A
			I

Remove & Replace Curb Ramp With Two New Directional Ramps or Equivalent.

R304.2.2
