Access Compliance Report Public Rights-of-Way (Curb Ramps)

Intersection ID: 13760	Main Street: EUCLID_AV	Cross Street: TEMPLETON_AV	Location: N
ADA ID: D9F6F3C108C5	Ramp Type: Perp	Initial Pass/Fail: Fail	Overall Compliance: No
			Severity Score: 1.25

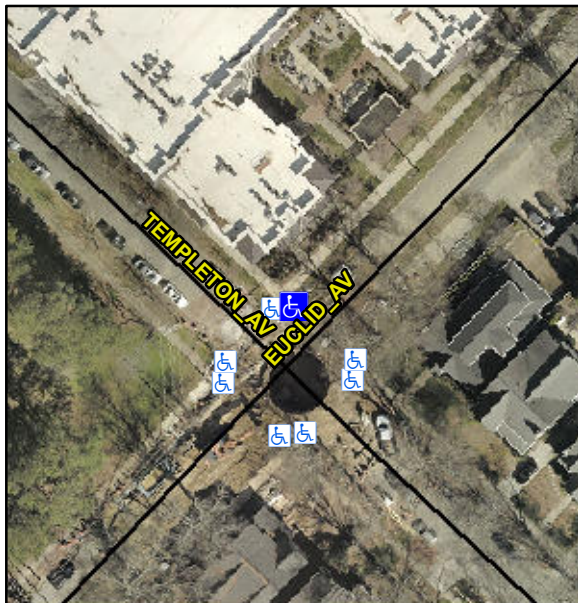
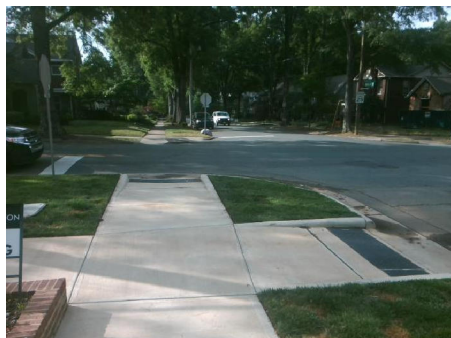
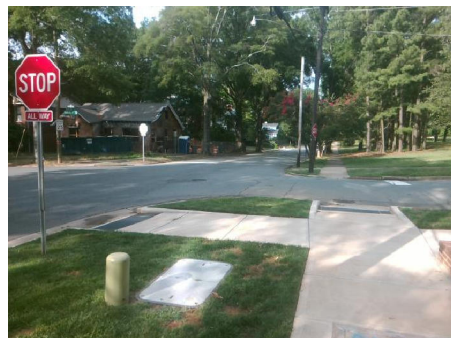
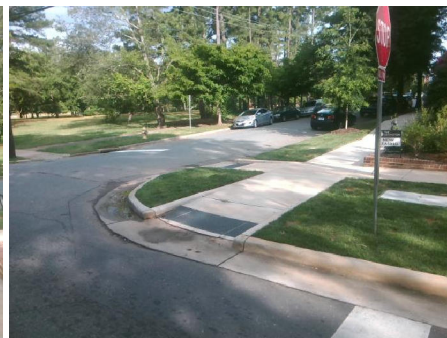
PROW/ADA:

R304.5.3

Compliance	Description	Data	Compliance	Description	Data
N/A	Ramp Length (in)	79.0	Yes	Ramp Slope (%)	5.3
Yes	Ramp Width (in)	74.0	No	Ramp XSlope (%)	3.3
N/A	Flare Type LT	N/A	N/A	Flare Type RT	N/A
N/A	Flare Slope LT (%)	N/A	N/A	Flare Slope RT (%)	N/A
N/A	Flare Traversable LT?	N/A	N/A	Flare Traversable RT?	N/A
N/A	Landing Length (in)	N/A	N/A	DWS Provided?	N/A
N/A	Landing Width (in)	N/A	N/A	DWS Contrast?	N/A
N/A	Landing Slope (%)	N/A	N/A	DWS Length (in)	N/A
N/A	Landing X Slope (%)	N/A	N/A	DWS Full Width?	N/A
N/A	Landing Curb? (Y/N)	N/A	N/A	DWS Offset (in)	N/A
N/A	Shared Landing?	N/A			
N/A	Gutter Ponding?	N/A	N/A	Gutter Slope (%)	N/A
N/A	Gutter Lip Ht (in)	1.0	N/A	Gutter X Slope (%)	N/A
N/A	Painted X Walk1?	No	N/A	Painted X Walk2?	N/A
	X Walk 1 Direction	To SE		X Walk 2 Direction	N/A
N/A	X Walk 1 Width (in)	N/A	N/A	X Walk 2 Width (in)	N/A
	X Walk 1 Slope (%)	3.1		X Walk 2 Slope (%)	N/A
	X Walk 1 X Slope (%)	2.1		X Walk 2 X Slope (%)	N/A

N/A	Ramp inside XWalk1?	N/A	N/A	Ramp inside XWalk2?	N/A
	Road Slope (%)	N/A	N/A	Clear Space?	N/A
	Road X Slope (%)	N/A	N/A	Clear Space to XWalk (in)	N/A
N/A	Any Obstructions?	N/A	N/A	Storm Grate/Utility Hazard?	N/A
	Obstruction Type			Storm Grate/Utility Type	
		N/A			N/A
			Yes	Surface Condition? (G/P)	Good

Possible Solutions:

Remove & Replace Entire Ramp.

Total Cost: \$ **1850.00**
