Access Compliance Report Public Rights-of-Way (Curb Ramps)

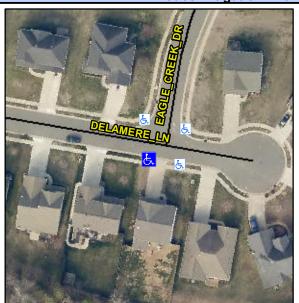
1850.00

Field Measurements/Component Compliance							
Comp	liance Description	Data	Comp	liance Description	Data		
N/A	Ramp Length (in)	46.5	Yes	Ramp Slope (%)	5.0		
No	Ramp Width (in)	47.0	No	Ramp XSlope (%)	3.9		
N/A	Flare Type LT	N/A	N/A	Flare Type RT	N/A		
N/A	Flare Slope LT (%)	N/A	N/A	Flare Slope RT (%)	N/A		
N/A	Flare Traversable LT?	N/A	N/A	Flare Traversable RT?	N/A		
N/A	Landing Length (in)	N/A	N/A	DWS Provided?	N/A		
N/A	Landing Width (in)	N/A	N/A	DWS Contrast?	N/A		
N/A	Landing Slope (%)	N/A	N/A	DWS Length (in)	N/A		
N/A	Landing X Slope (%)	N/A	N/A	DWS Full Width?	N/A		
N/A	Landing Curb? (Y/N)	N/A	N/A	DWS Offset (in)	N/A		
N/A	Shared Landing?	N/A					
N/A	Gutter Ponding?	N/A	N/A	Gutter Slope (%)	N/A		
N/A	Gutter Lip Ht (in)	N/A	N/A	Gutter X Slope (%)	N/A		
N/A	Painted X Walk1?	No	N/A	Painted X Walk2?	N/A		
	X Walk 1 Direction	To N		X Walk 2 Direction	N/A		
N/A	X Walk 1 Width (in)	N/A	N/A	X Walk 2 Width (in)	N/A

Street 1 Name	DELAMERE LN
Stop Condition-Street 2	None
Street 2 Name	N/A
Stop Condition-Street 1	N/A
