Access Compliance Report

Public Rights-of-Way

(Curb Ramps)

Intersection ID: 29178	Main Street: HARRIS_CENTER_DR	Cross Street: STATESVILLE_RD	Location: SE
ADA ID: DA05AC684795	Ramp Type: Perp	Initial Pass/Fail: Fail	Overall Compliance: No
Severity Score: 12.5			
Codes/Mitigation Info/Possible Solution		Field Measurements/Component Compliance

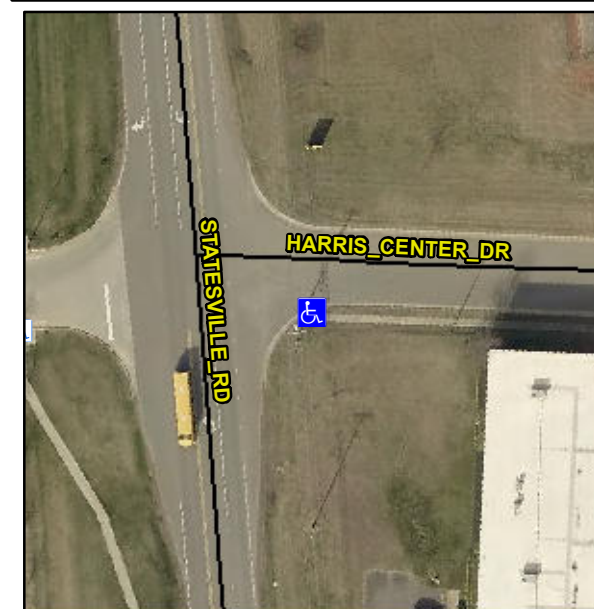
Not Found, R304.2.2

Compliance	Description	Data	Compliance	Description	Data
N/A	Ramp Length (in)	37.0	No	Ramp Slope (%)	9.9
Yes	Ramp Width (in)	49.0	Yes	Ramp XSlope (%)	1.1
N/A	Flare Type LT	N/A	N/A	Flare Type RT	N/A
N/A	Flare Slope LT (%)	N/A	N/A	Flare Slope RT (%)	N/A
N/A	Flare Traversable LT?	N/A	N/A	Flare Traversable RT?	N/A
N/A	Landing Length (in)	N/A	N/A	DWS Provided?	N/A
N/A	Landing Width (in)	N/A	N/A	DWS Contrast?	N/A
N/A	Landing Slope (%)	N/A	N/A	DWS Length (in)	N/A
N/A	Landing X Slope (%)	N/A	N/A	DWS Full Width?	N/A
N/A	Landing Curb? (Y/N)	N/A	N/A	DWS Offset (in)	N/A
N/A	Shared Landing?	N/A			
N/A	Gutter Ponding?	N/A	N/A	Gutter Slope (%)	N/A
N/A	Gutter Lip Ht (in)	N/A	N/A	Gutter X Slope (%)	N/A
N/A	Painted X Walk1?	No	N/A	Painted X Walk2?	N/A
	X Walk 1 Direction	To N		X Walk 2 Direction	N/A
N/A	X Walk 1 Width (in)	N/A	N/A	X Walk 2 Width (in)	N/A
	X Walk 1 Slope (%)	0.5		X Walk 2 Slope (%)	N/A
	X Walk 1 X Slope (%)	1.6		X Walk 2 X Slope (%)	N/A

N/A	Ramp inside XWalk1?	N/A	N/A	Ramp inside XWalk2?	N/A
	Road Slope (%)	N/A	N/A	Clear Space?	N/A
	Road X Slope (%)	N/A	N/A	Clear Space to XWalk (in)	N/A
N/A	Any Obstructions?	N/A	N/A	Storm Grate/Utility Hazard?	N/A
	Obstruction Type			Storm Grate/Utility Type	
		N/A			N/A
			Yes	Surface Condition? (G/P)	Good

Possible Solutions:

Remove & Replace Entire Ramp.

Total Cost: \$ 1850.00
