# Access Compliance Report

## Public Rights-of-Way

| Intersection ID: 16139 | Main Street: BILTMORE_DR | Cross Street: CHEROKEE_RD | Location: N |
| ADA ID: DA0774130DAD | Ramp Type: Directional1 | Initial Pass/Fail: Fail | Overall Compliance: No |

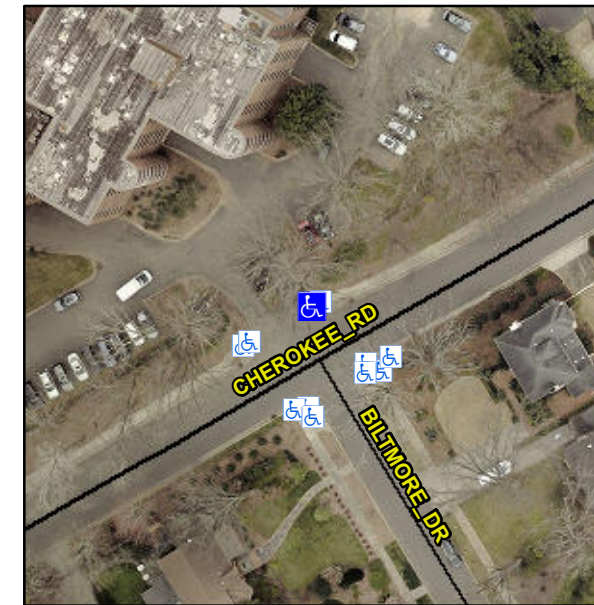
| | | Severity Score: 8.75 | |

| Compliance | Description | Data | Compliance | Description | Data |
|---|---|---|---|---|---|
| No | Ramp Width (in) | 47.0 | N/A | Grade Break Slope (%) | 0.0 |

**Remove & Replace Entire Ramp.**

**R304.5.1**
