Access Compliance Report

Public Rights-of-Way

(Curb Ramps)

Intersection ID: 9158	Main Street: MORETZ_AV	Cross Street: RACHEL_ST	Location: SW
ADA ID: DA3B6BC7DB58	Ramp Type: Para	Initial Pass/Fail: Fail	Overall Compliance: No
Codes/Mitigation Info/Possible Solution		Field Measurements/Component Compliance

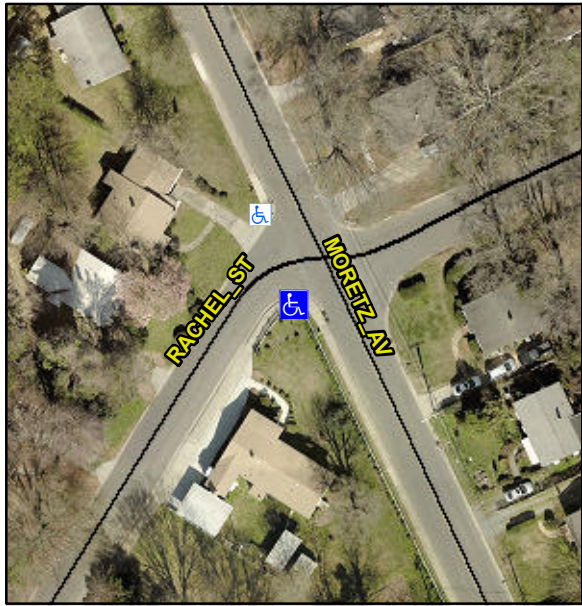
Compliance	Description	Data	Compliance	Description	Data
N/A	Ramp Length LT (in)	33.5	N/A	Ramp Length RT (in)	38.0
Yes	Ramp Width LT (in)	60.5	Yes	Ramp Width RT (in)	59.0
No	Ramp Slope LT (%)	8.6	No	Ramp Slope RT (%)	15.8
Yes	Ramp XSlope LT (%)	0.5	Yes	Ramp XSlope RT (%)	1.9
N/A	Landing Length (in)	N/A	N/A	DWS Provided?	N/A
N/A	Landing Width (in)	N/A	N/A	DWS Contrast?	N/A
N/A	Landing Slope (%)	N/A	N/A	DWS Length (in)	N/A
N/A	Landing X Slope (%)	N/A	N/A	DWS Full Width?	N/A
N/A	Landing Curb? (Y/N)	N/A	N/A	DWS Offset (in)	N/A
N/A	Shared Landing?	N/A			
N/A	Gutter Ponding?	N/A	N/A	Gutter Slope (%)	N/A
N/A	Gutter Lip Ht (in)	1.0	N/A	Gutter X Slope (%)	N/A
N/A	Painted X Walk1?	No	N/A	Painted X Walk2?	N/A
	X Walk 1 Direction	To NW		X Walk 2 Direction	N/A
N/A	X Walk 1 Width (in)	N/A	N/A	X Walk 2 Width (in)	N/A
	X Walk 1 Slope (%)	3.1		X Walk 2 Slope (%)	N/A
	X Walk 1 X Slope (%)	1.6		X Walk 2 X Slope (%)	N/A
N/A	Ramp inside XWalk1?	N/A	N/A	Ramp inside XWalk2?	N/A

Road Slope (%)	N/A	N/A	Clear Space?	N/A
	Road X Slope (%)	N/A	N/A	Clear Space to XWalk (in)	N/A
N/A	Any Obstructions?	N/A	N/A	Storm Grate/Utility Hazard?	N/A
	Obstruction Type			Storm Grate/Utility Type	
		N/A			N/A
			Yes	Surface Condition? (G/P)	Good
			N/A	Curb Slope (%)	20.2

Remove & Replace Entire Ramp.

R304.3.2
