Access Compliance Report Public Rights-of-Way (Curb Ramps)

Intersection ID: 44012	Main Street: BRADWELL_DR	Cross Street: LANGHAM_CT	Location: SW
ADA ID: DA456E977DFD	Ramp Type: PerpDiag	Initial Pass/Fail: Fail	Overall Compliance: No
Codes/Mitigation Info/Possible Solution			Field Measurements/Component Compliance

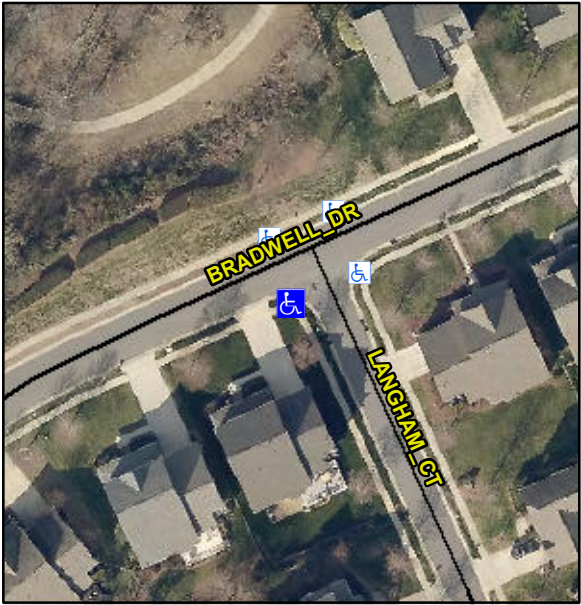
PROW/ADA:
Not Found, R304.5.1, R304.5.3

Compliance	Description	Data	Compliance	Description	Data
N/A	Ramp Length (in)	48.0	Yes	Ramp Slope (%)	5.4
No	Ramp Width (in)	36.0	No	Ramp XSlope (%)	6.7
N/A	Flare Type LT	N/A	N/A	Flare Type RT	N/A
N/A	Flare Slope LT (%)	N/A	N/A	Flare Slope RT (%)	N/A
N/A	Flare Traversable LT?	N/A	N/A	Flare Traversable RT?	N/A
N/A	Landing Length (in)	N/A	N/A	DWS Provided?	N/A
N/A	Landing Width (in)	N/A	N/A	DWS Contrast?	N/A
N/A	Landing Slope (%)	N/A	N/A	DWS Length (in)	N/A
N/A	Landing X Slope (%)	N/A	N/A	DWS Full Width?	N/A
N/A	Landing Curb? (Y/N)	N/A	N/A	DWS Offset (in)	N/A
N/A	Shared Landing?	N/A			
N/A	Gutter Ponding?	N/A	N/A	Gutter Slope (%)	N/A
N/A	Gutter Lip Ht (in)	N/A	N/A	Gutter X Slope (%)	N/A
N/A	Painted X Walk1?	No	N/A	Painted X Walk2?	No
	X Walk 1 Direction	To E		X Walk 2 Direction	To N
N/A	X Walk 1 Width (in)	N/A	N/A	X Walk 2 Width (in)	N/A
	X Walk 1 Slope (%)	2.2		X Walk 2 Slope (%)	1.6
	X Walk 1 X Slope (%)	2.4		X Walk 2 X Slope (%)	2.8

N/A	Ramp inside XWalk1?	N/A	N/A	Ramp inside XWalk2?	N/A
	Road Slope (%)	3.7	N/A	Clear Space?	N/A
	Road X Slope (%)	1.6	N/A	Clear Space to XWalk (in)	N/A
N/A	Any Obstructions?	N/A	N/A	Storm Grate/Utility Hazard?	N/A
	Obstruction Type			Storm Grate/Utility Type	
		N/A			N/A
			Yes	Surface Condition? (G/P)	Good

Possible Solutions:
Remove & Replace Curb Ramp With Two New Directional Ramps or Equivalent.
