Access Compliance Report

Public Rights-of-Way

(Curb Ramps)

Intersection ID: 49295	Main Street: CREEKSIDE_PARK_RD	Cross Street: ROYAL_WINCHESTER_DR	Location: SE
ADA ID: DA502CFDBB88	Ramp Type: Perp	Initial Pass/Fail: Fail	Overall Compliance: No
Severity Score: 8.75			
Codes/Mitigation Info/Possible Solution		Field Measurements/Component Compliance

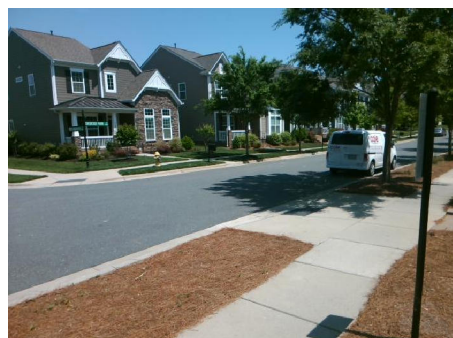
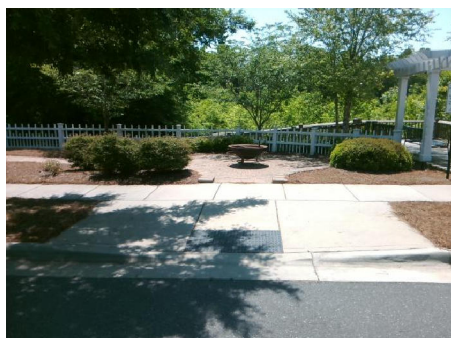
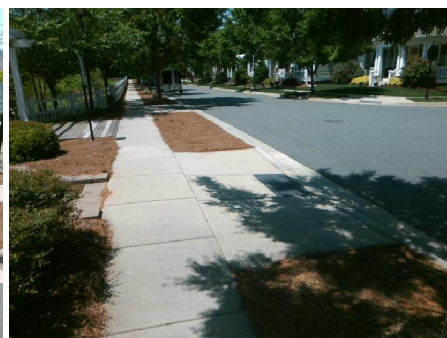
Compliance	Description	Data	Compliance	Description	Data
N/A	Ramp Length (in)	72.0	Yes	Ramp Slope (%)	8.3
No	Ramp Width (in)	47.0	Yes	Ramp XSlope (%)	1.3
N/A	Flare Type LT	N/A	N/A	Flare Type RT	N/A
N/A	Flare Slope LT (%)	N/A	N/A	Flare Slope RT (%)	N/A
N/A	Flare Traversable LT?	N/A	N/A	Flare Traversable RT?	N/A
N/A	Landing Length (in)	N/A	N/A	DWS Provided?	N/A
N/A	Landing Width (in)	N/A	N/A	DWS Contrast?	N/A
N/A	Landing Slope (%)	N/A	N/A	DWS Length (in)	N/A
N/A	Landing X Slope (%)	N/A	N/A	DWS Full Width?	N/A
N/A	Landing Curb? (Y/N)	N/A	N/A	DWS Offset (in)	N/A
N/A	Shared Landing?	N/A			
N/A	Gutter Ponding?	N/A	N/A	Gutter Slope (%)	N/A
N/A	Gutter Lip Ht (in)	N/A	N/A	Gutter X Slope (%)	N/A
N/A	Painted X Walk1?	No	N/A	Painted X Walk2?	N/A
	X Walk 1 Direction	To NW		X Walk 2 Direction	N/A
N/A	X Walk 1 Width (in)	N/A	N/A	X Walk 2 Width (in)	N/A
	X Walk 1 Slope (%)	0.9		X Walk 2 Slope (%)	N/A
	X Walk 1 X Slope (%)	0.7		X Walk 2 X Slope (%)	N/A

N/A	Ramp inside XWalk1?	N/A	N/A	Ramp inside XWalk2?	N/A
	Road Slope (%)	N/A	N/A	Clear Space?	N/A
	Road X Slope (%)	N/A	N/A	Clear Space to XWalk (in)	N/A
N/A	Any Obstructions?	N/A	N/A	Storm Grate/Utility Hazard?	N/A
	Obstruction Type			Storm Grate/Utility Type	
		N/A			N/A
			Yes	Surface Condition? (G/P)	Good

Possible Solutions:

Remove & Replace Entire Ramp.

Not Found, R304.5.1

Total Cost: \$ 1850.00
