Access Compliance Report Public Rights-of-Way (Curb Ramps)

Intersection ID: 24993 Main Street: TRESANTON DR **Cross Street: TYNE_CT** Location: SW ADA ID: DA63F8BB473E Ramp Type: PerpDiag Initial Pass/Fail: Fail **Overall Compliance: No Severity Score:** 25

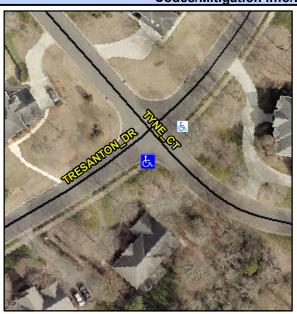
ot Found, R304.2.2, R304.5.3

Field Measurements/Component Compliance							
Compl	iance Description	Data	Comp	liance	Description	Data	
N/A	Ramp Length (in)	32.0	No	Ramp	Slope (%)	9.7	
Yes	Ramp Width (in)	48.0	No	Ramp	XSlope (%)	6.9	
N/A	Flare Type LT	N/A	N/A	Flare	Type RT	N/A	
N/A	Flare Slope LT (%)	N/A	N/A	Flare	Slope RT (%)	N/A	
N/A	Flare Traversable LT?	N/A	N/A	Flare	Traversable RT?	N/A	
N/A	Landing Length (in)	N/A	N/A	DWS	Provided?	N/A	
N/A	Landing Width (in)	N/A	N/A	DWS	Contrast?	N/A	
N/A	Landing Slope (%)	N/A	N/A	DWS	Length (in)	N/A	
N/A	Landing X Slope (%)	N/A	N/A	DWS	Full Width?	N/A	
N/A	Landing Curb? (Y/N)	N/A	N/A	DWS	Offset (in)	N/A	
N/A	Shared Landing?	N/A					
N/A	Gutter Ponding?	N/A	N/A	Gutte	r Slope (%)	N/A	
N/A	Gutter Lip Ht (in)	N/A	N/A	Gutte	r X Slope (%)	N/A	
N/A	Painted X Walk1?	No	N/A	Paint	ed X Walk2?	No	
	X Walk 1 Direction	To NE		X Wa	lk 2 Direction	To NW	
N/A	X Walk 1 Width (in)	N/A	N/A	X Wa	lk 2 Width (in)	N/A

X Walk 1 Slope (%)	1.5		X Wa	lk 2 Slope (%)	2.5	
	X Walk 1 X Slope (%)	2.1		X Wa	lk 2 X Slope (%)	1.1	
N/A	Ramp inside XWalk1?	N/A	N/A	Ramp	inside XWalk2?	N/A	
	Road Slope (%)	1.8	N/A	Clear	Space?	N/A	
	Road X Slope (%)	1.6	N/A	Clear	Space to XWalk (in)	N/A	
N/A	Any Obstructions?	N/A	N/A	Storm	n Grate/Utility Hazard?	N/A	
	Obstruction Type			Storm	n Grate/Utility Type		
		N/A				N/A	
			Yes	Surfa	ce Condition? (G/P)	Good

Street 1 Name Stop Condition-Street 2 Street 2 Name Stop Condition-Street 1 Possible Solutions: Remove & Replace Curb Ramp With **Two New Directional Ramps or** Equivalent. N/A

3200.00
