## Access Compliance Report Public Rights-of-Way (Curb Ramps)

Intersection ID: 10020721 Main Street: BEATTIES_FORD_RD			Cross Street: BEATTIES_FORD_RD					Location:	W		
ADA ID: DA6DE814F3D6	DA ID: DA6DE814F3D6 Ramp Type: Perp			Initial P	Initial Pass/Fail: Pass Overall Compliance: No				o Severity Score:	10	
Codes/Mitigation Info/Possible Solution					Field Measurements/Component Compliance						
		Possible Solutions:			Compliance Description			Data Compliance Description			
	Transferrer	Remove & Replace Er	ntire Ramp.		N/A	Ramp Length (in)	93.0	Yes	Ramp Slope (%)	5.4	
Apple the factor of the	1 1 1 1 1 1 1 1 1 1 1 1 1 1 1 1 1 1 1		-		Yes	Ramp Width (in)	48.0	Yes	Ramp XSlope (%)	0.7

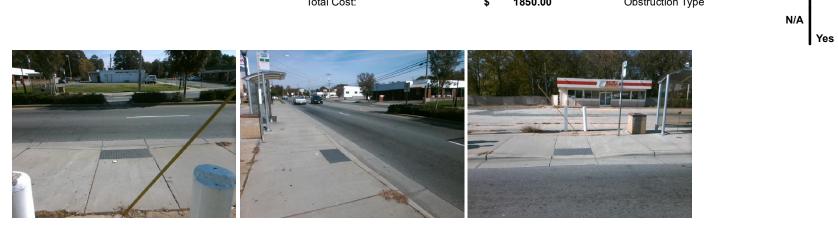
- ( ]. Laurandi				N/A	Flare Type LT	Sloped	N/A	Flare Type RT	N/A	
					N/A	Flare Slope LT (%)	3.8	Yes	Flare Slope RT (%)	6.9	
	· CALIBRAD STED				N/A	Flare Traversable LT?	Yes	N/A	Flare Traversable RT?	Yes	
	ALL .				No	Landing Length (in)	N/A	Yes	DWS Provided?	Yes

1. 28.	Surveyor Notes:			No	Landing Width (in)	N/A	Yes	DWS Contrast?	Yes	
E H	G.	N/A			No	Landing Slope (%)	N/A	Yes	DWS Length (in)	24.0	
	· A China				No	Landing X Slope (%)	N/A	Yes	DWS Full Width?	Yes	
					N/A	Landing Curb? (Y/N)	No	Yes	DWS Offset (in)	0.0	
	DR_WEBBER_AV				N/A	Shared Landing?	No				
	5	PROW/ADA:			Yes	Gutter Ponding?	No	Yes	Gutter Slope (%)	3.8	
	E CONSTRACT	Not Found, R304.2.1,	R304.2.2-Pe	erp.	Yes	Gutter Lip Ht (in)	0.0	Yes	Gutter X Slope (%)	0.7	
DR_WEBBER_AV		R304.3.2-Para, R304.5			N/A	Painted X Walk1?	No	N/A	Painted X Walk2?	N/A	
	6					X Walk 1 Direction	To E		X Walk 2 Direction	N/A	
					N/A	X Walk 1 Width (in)	N/A	N/A	X Walk 2 Width (in)	N/A	
Street 1 Name B	EATTIES FORD RD	-				X Walk 1 Slope (%)	2.0		X Walk 2 Slope (%)	N/A	
Stop Condition-Street 2	None					X Walk 1 X Slope (%)	1.2		X Walk 2 X Slope (%)	N/A	
Street 2 Name	N/A				N/A	Ramp inside XWalk1?	N/A	N/A	Ramp inside XWalk2?	N/A

Stop Condition-Street 1	N/A					Road Slope (%)	N/A	N/A	Clear Space?	Yes	
						Road X Slope (%)	N/A	N/A	Clear Space to XWalk (in)	N/A	
					Yes	Any Obstructions?	No	Yes	Storm Grate/Utility Hazard?	No	
		Total Cost:	\$ 1	850.00		Obstruction Type			Storm Grate/Utility Type		
							N/A			N/A
