Access Compliance Report

Public Rights-of-Way

(Curb Ramps)

Intersection ID: N/A	Main Street: BEREWICK COMMONS PKY	Cross Street: GLENBURN LN	Location: SW
ADA ID: DA74940FE322	Ramp Type: PerpDiag	Initial Pass/Fail: Fail	Overall Compliance: No
Severity Score: 21.25			
Codes/Mitigation Info/Possible Solution		Field Measurements/Component Compliance

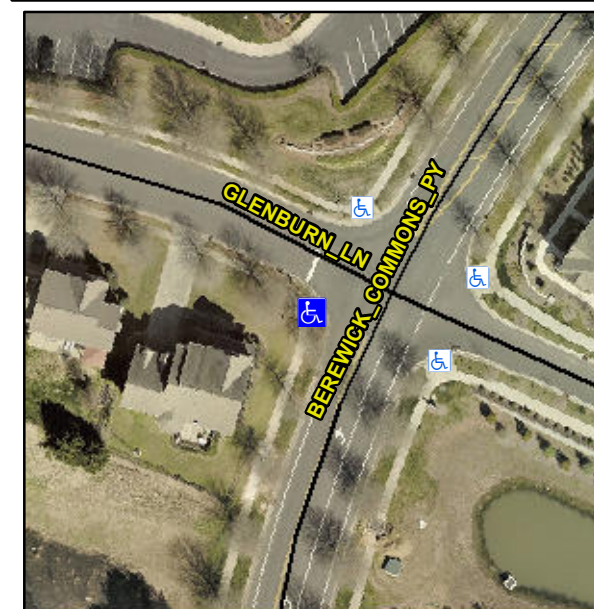
Compliance	Description	Data	Compliance	Description	Data
N/A	Ramp Length (in)	90.0	Yes	Ramp Slope (%)	6.5
No	Ramp Width (in)	45.0	No	Ramp XSlope (%)	6.8
N/A	Flare Type LT	N/A	N/A	Flare Type RT	N/A
N/A	Flare Slope LT (%)	N/A	N/A	Flare Slope RT (%)	N/A
N/A	Flare Traversable LT?	N/A	N/A	Flare Traversable RT?	N/A
N/A	Landing Length (in)	N/A	N/A	DWS Provided?	N/A
N/A	Landing Width (in)	N/A	N/A	DWS Contrast?	N/A
N/A	Landing Slope (%)	N/A	N/A	DWS Length (in)	N/A
N/A	Landing X Slope (%)	N/A	N/A	DWS Full Width?	N/A
N/A	Landing Curb? (Y/N)	N/A	N/A	DWS Offset (in)	N/A
N/A	Shared Landing?	N/A			
N/A	Gutter Ponding?	N/A	N/A	Gutter Slope (%)	N/A
N/A	Gutter Lip Ht (in)	N/A	N/A	Gutter X Slope (%)	N/A
N/A	Painted X Walk1?	No	N/A	Painted X Walk2?	No
	X Walk 1 Direction	To SE		X Walk 2 Direction	To NE
N/A	X Walk 1 Width (in)	N/A	N/A	X Walk 2 Width (in)	N/A
	X Walk 1 Slope (%)	0.5		X Walk 2 Slope (%)	4.7
	X Walk 1 X Slope (%)	6.7		X Walk 2 X Slope (%)	3.3

N/A	Ramp inside XWalk1?	N/A	N/A	Ramp inside XWalk2?	N/A
	Road Slope (%)	5.6	N/A	Clear Space?	N/A
	Road X Slope (%)	4.2	N/A	Clear Space to XWalk (in)	N/A
N/A	Any Obstructions?	N/A	N/A	Storm Grate/Utility Hazard?	N/A
	Obstruction Type			Storm Grate/Utility Type	
		N/A			N/A
			Yes	Surface Condition? (G/P)	Good

Possible Solutions:

Remove & Replace Curb Ramp With Two New Directional Ramps or Equivalent.
