Access Compliance Report Public Rights-of-Way (Curb Ramps)

Intersection ID: 13345 Main Street: COMMONWEALTH_AV Cross Street: THOMAS_AV Location: NW
ADA ID: DA8D5AD7A24A Ramp Type: Perp Initial Pass/Fail: Fail Overall Compliance: No Severity Score: 8.75

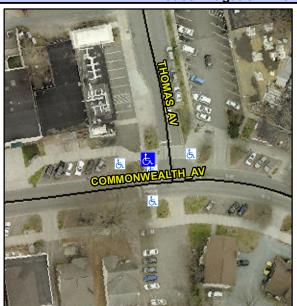
Field Measurements/Component Compliance								
Compl	iance Description	Data	Compl	iance Description	Data			
N/A	Ramp Length (in)	59.0	Yes	Ramp Slope (%)	6.7			
No	Ramp Width (in)	46.5	Yes	Ramp XSlope (%)	1.1			
N/A	Flare Type LT	N/A	N/A	Flare Type RT	N/A			
N/A	Flare Slope LT (%)	N/A	N/A	Flare Slope RT (%)	N/A			
N/A	Flare Traversable LT?	N/A	N/A	Flare Traversable RT?	N/A			
N/A	Landing Length (in)	N/A	N/A	DWS Provided?	N/A			
N/A	Landing Width (in)	N/A	N/A	DWS Contrast?	N/A			
N/A	Landing Slope (%)	N/A	N/A	DWS Length (in)	N/A			
N/A	Landing X Slope (%)	N/A	N/A	DWS Full Width?	N/A			
N/A	Landing Curb? (Y/N)	N/A	N/A	DWS Offset (in)	N/A			
N/A	Shared Landing?	N/A						
N/A	Gutter Ponding?	N/A	N/A	Gutter Slope (%)	N/A			
N/A	Gutter Lip Ht (in)	N/A	N/A	Gutter X Slope (%)	N/A			
N/A	Painted X Walk1?	Yes	N/A	Painted X Walk2?	N/A			
	X Walk 1 Direction	To E		X Walk 2 Direction	N/A			
N/A	X Walk 1 Width (in)	143.5	N/A	X Walk 2 Width (in)	N/A

X Walk 1 Slope (%)	3.3		X Walk 2 Slope (%)	N/A			
	X Walk 1 X Slope (%)	0.2		X Walk 2 X Slope (%)	N/A			
N/A	Ramp inside XWalk1?	Yes	N/A	Ramp inside XWalk2?	N/A			
	Road Slope (%)	N/A	N/A	Clear Space?	N/A			
	Road X Slope (%)	N/A	N/A	Clear Space to XWalk (in)	N/A			
N/A	Any Obstructions?	N/A	N/A	Storm Grate/Utility Hazard?	N/A			
	Obstruction Type			Storm Grate/Utility Type				
		N/A			N/A			
			Yes	Surface Condition? (G/P)	Good			
-1

ossible Solution	
Possible Solutions:	Comp
Remove & Replace Entire Ramp.	N/A
	No
	N/A
	N/A
	N/A
	N/A
Surveyor Notes:	N/A
N/A	N/A
	N/A
	N/A
	N/A
PROW/ADA:	N/A
Not Found, R304.5.1	N/A
	N/A
	N/A
	N/A
