## **Access Compliance Report Public Rights-of-Way** (Curb Ramps)

Intersection ID: 54317 Main Street: BELMONT MANSION DR **Cross Street: SOUTHBRIDGE FOREST DR** Location: **ADA ID: DAA7FA1BDF25** Ramp Type: PerpDiag Initial Pass/Fail: Fail **Overall Compliance: No Severity Score:** 12.5

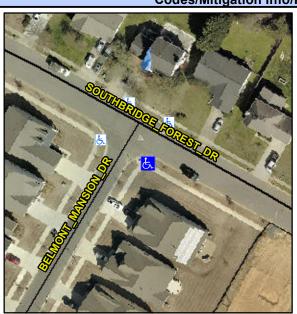
Field Measurem	ents/C	ompon	ent C	ompliance	
	Comp	Compliance Description		Compliance		Description	Data
	N/A	Ramp Length (in)	94.0	Yes	Ram	Slope (%)	6.3
	Yes	Ramp Width (in)	48.0	No	Ramp	XSlope (%)	6.1
	N/A	Flare Type LT	N/A	N/A	Flare	Type RT	N/A
	N/A	Flare Slope LT (%)	N/A	N/A	Flare	Slope RT (%)	N/A
	N/A	Flare Traversable LT?	N/A	N/A	Flare	Traversable RT?	N/A
	N/A	Landing Length (in)	N/A	N/A	DWS	Provided?	N/A
	N/A	Landing Width (in)	N/A	N/A	DWS	Contrast?	N/A
	N/A	Landing Slope (%)	N/A	N/A	DWS	Length (in)	N/A
	N/A	Landing X Slope (%)	N/A	N/A	DWS	Full Width?	N/A
	N/A	Landing Curb? (Y/N)	N/A	N/A	DWS	Offset (in)	N/A
	N/A	Shared Landing?	N/A				
	N/A	Gutter Ponding?	N/A	N/A	Gutte	r Slope (%)	N/A
	N/A	Gutter Lip Ht (in)	1.0	N/A	Gutte	r X Slope (%)	N/A
	N/A	Painted X Walk1?	No	N/A	Paint	ed X Walk2?	No
		X Walk 1 Direction	To NE		X Wa	lk 2 Direction	To NW
	N/A	X Walk 1 Width (in)	N/A	N/A	X Wa	lk 2 Width (in)	N/A

X Walk 1 Slope (%)	2.9		X Wa	lk 2 Slope (%)	3.0
		X Walk 1 X Slope (%)	3.8		X Wa	lk 2 X Slope (%)	1.1
	N/A	Ramp inside XWalk1?	N/A	N/A	Ram	inside XWalk2?	N/A
		Road Slope (%)	3.9	N/A	Clear	Space?	N/A
		Road X Slope (%)	3.4	N/A	Clear	Space to XWalk (in)	N/A
	N/A	Any Obstructions?	N/A	N/A	Storn	n Grate/Utility Hazard?	N/A
		Obstruction Type			Storn	n Grate/Utility Type	
			N/A				N/A
				Yes	Surfa	ce Condition? (G/P)	Good
\$4.				-

Possible Solutions: Remove & Replace Curb Ramp With **Two New Directional Ramps or** Equivalent. Surveyor Notes: N/A PROW/ADA: R304.5.3

Total Cost: 3200.00
