# Access Compliance Report

## Public Rights-of-Way

| Intersection ID: 6481 | Main Street: LOTHAR RIDGE LN | Cross Street: SLATER SPRINGS DR | Location: NW |
| ADA ID: DAAD98D6844E | Ramp Type: Perp | Initial Pass/Fail: Pass | Overall Compliance: No |

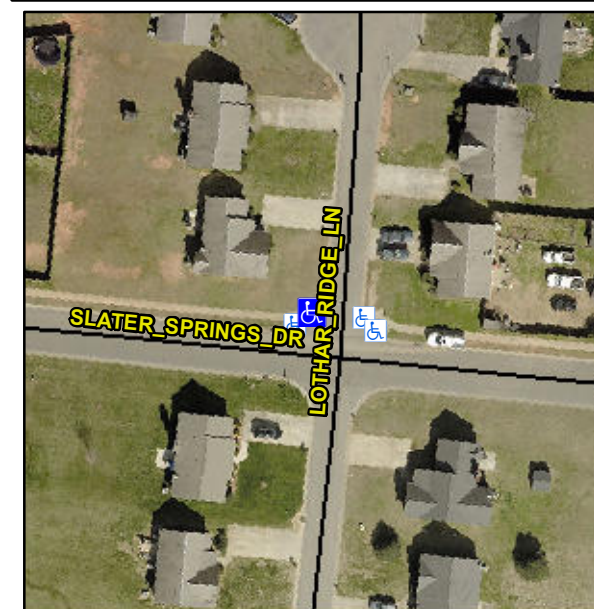
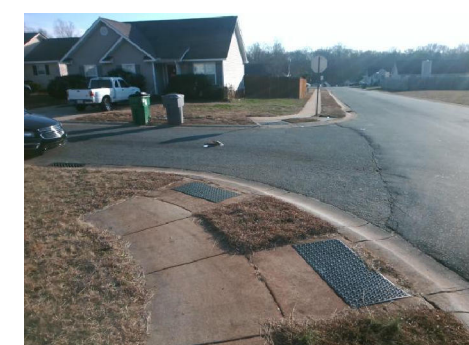
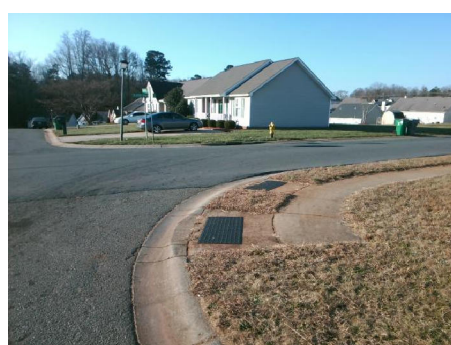
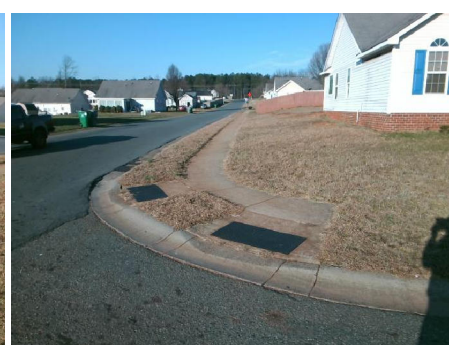
**Not Found, R304.5.3, R305.1.4,  
R305.2, R304.5.4**

| Compliance | Description | Data | Compliance | Description | Data |
|---|---|---|---|---|---|
| Yes | Ramp Width (in) | 54.5 | No | Ramp XSlope (%) | 2.6 |
| Yes | Landing X Slope (%) | 1.0 | No | DWS Full Width? | No |
| N/A | Landing Curb? (Y/N) | No | No | DWS Offset (in) | 6.0 |
| Yes | Gutter Ponding? | No | No | Gutter Slope (%) | 11.6 |

**Remove & Replace Entire Ramp.  
Remove & Replace Gutter.**
