Access Compliance Report Public Rights-of-Way (Curb Ramps)

Main Street: PROVIDENCE RD Cross Street: PROVIDENCE COUNTRY CLUB DR Intersection ID: 27788 Location: NE 10 **ADA ID: DAAFFEFC390F** Ramp Type: Combination1 Initial Pass/Fail: Fail **Overall Compliance: No Severity Score:**

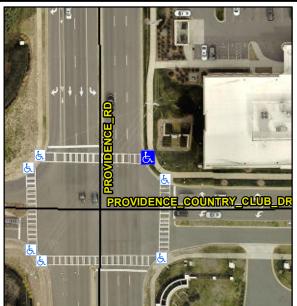
Signal Street 1 Name **PROVIDENCE RD** Stop Condition-Street 1 Street 2 Name N/A Stop Condition-Street 2 N/A Possible Solutions: Compliance Description Remove & Replace Entire Ramp. N/A Yes Yes No N/A No Surveyor Notes: N/A N/A RT RP < 5% PROW/ADA: Not Found, R304.5.1, R304.5.3
