# Access Compliance Report

## Public Rights-of-Way

### (Curb Ramps)

Intersection ID: 30544	Main Street: STONECROFT_PARK_DR	Cross Street: SUMMERHILL_RIDGE_DR	Location: SW
ADA ID: DAB80890353E	Ramp Type: PerpDiag	Initial Pass/Fail: Fail	Overall Compliance: No
Severity Score: 33.75			
Codes/Mitigation Info/Possible Solution		Field Measurements/Component Compliance

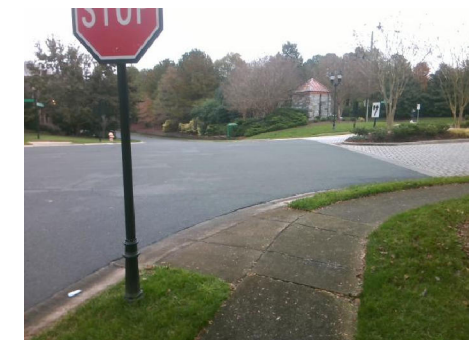
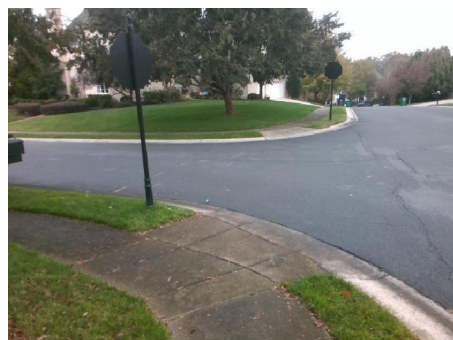
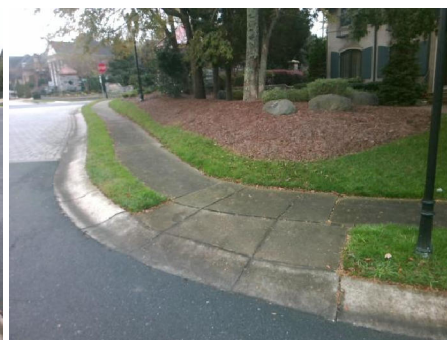
**Not Found, R304.5.1, R304.5.3**

Compliance	Description	Data	Compliance	Description	Data
N/A	Ramp Length (in)	30.0	Yes	Ramp Slope (%)	7.1
No	Ramp Width (in)	43.0	No	Ramp XSlope (%)	7.4
N/A	Flare Type LT	N/A	N/A	Flare Type RT	N/A
N/A	Flare Slope LT (%)	N/A	N/A	Flare Slope RT (%)	N/A
N/A	Flare Traversable LT?	N/A	N/A	Flare Traversable RT?	N/A
N/A	Landing Length (in)	N/A	N/A	DWS Provided?	N/A
N/A	Landing Width (in)	N/A	N/A	DWS Contrast?	N/A
N/A	Landing Slope (%)	N/A	N/A	DWS Length (in)	N/A
N/A	Landing X Slope (%)	N/A	N/A	DWS Full Width?	N/A
N/A	Landing Curb? (Y/N)	N/A	N/A	DWS Offset (in)	N/A
N/A	Shared Landing?	N/A			
N/A	Gutter Ponding?	N/A	N/A	Gutter Slope (%)	N/A
N/A	Gutter Lip Ht (in)	N/A	N/A	Gutter X Slope (%)	N/A
N/A	Painted X Walk1?	No	N/A	Painted X Walk2?	No
	X Walk 1 Direction	To NE		X Walk 2 Direction	To NW
N/A	X Walk 1 Width (in)	N/A	N/A	X Walk 2 Width (in)	N/A
	X Walk 1 Slope (%)	4.5		X Walk 2 Slope (%)	2.4
	X Walk 1 X Slope (%)	4.1		X Walk 2 X Slope (%)	4.2

N/A	Ramp inside XWalk1?	N/A	N/A	Ramp inside XWalk2?	N/A
	Road Slope (%)	5.2	N/A	Clear Space?	N/A
	Road X Slope (%)	1.9	N/A	Clear Space to XWalk (in)	N/A
N/A	Any Obstructions?	N/A	N/A	Storm Grate/Utility Hazard?	N/A
	Obstruction Type			Storm Grate/Utility Type	
		N/A			N/A
			Yes	Surface Condition? (G/P)	Good

**Remove & Replace Curb Ramp With Two New Directional Ramps or Equivalent.**
