Access Compliance Report

Public Rights-of-Way

(Curb Ramps)

Intersection ID: 9897		Main Street: N_GRAHAM_ST		Cross Street: W_24TH_ST		Location:		SE	
ADA ID: DADDACCBCF5D		Ramp Type: PerpDiag		Initial Pass/Fail: Fail		Overall Compliance: No		Severity Score: 10	
Codes/Mitigation Info/Possible Solution					Field Measurements/Component Compliance

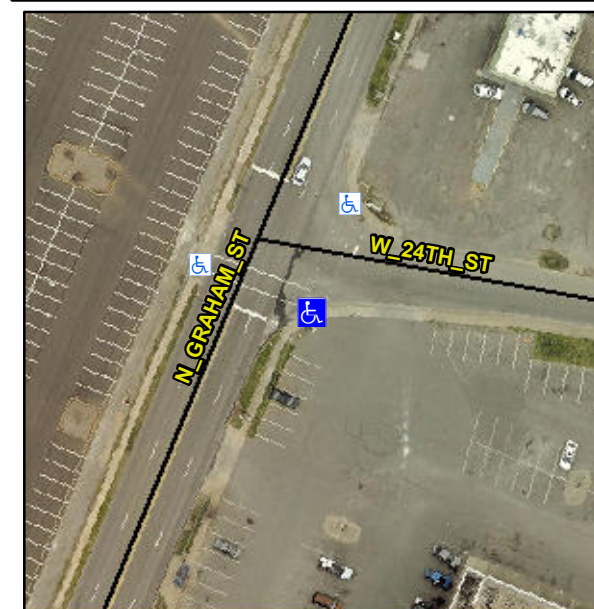
Not Found, R304.5.1, R304.5.3

Compliance	Description	Data	Compliance	Description	Data
N/A	Ramp Length (in)	60.0	Yes	Ramp Slope (%)	7.6
No	Ramp Width (in)	43.0	No	Ramp XSlope (%)	2.9
N/A	Flare Type LT	N/A	N/A	Flare Type RT	N/A
N/A	Flare Slope LT (%)	N/A	N/A	Flare Slope RT (%)	N/A
N/A	Flare Traversable LT?	N/A	N/A	Flare Traversable RT?	N/A
N/A	Landing Length (in)	N/A	N/A	DWS Provided?	N/A
N/A	Landing Width (in)	N/A	N/A	DWS Contrast?	N/A
N/A	Landing Slope (%)	N/A	N/A	DWS Length (in)	N/A
N/A	Landing X Slope (%)	N/A	N/A	DWS Full Width?	N/A
N/A	Landing Curb? (Y/N)	N/A	N/A	DWS Offset (in)	N/A
N/A	Shared Landing?	N/A			
N/A	Gutter Ponding?	N/A	N/A	Gutter Slope (%)	N/A
N/A	Gutter Lip Ht (in)	0.5	N/A	Gutter X Slope (%)	N/A
N/A	Painted X Walk1?	Yes	N/A	Painted X Walk2?	Yes
	X Walk 1 Direction	To NE		X Walk 2 Direction	To NW
N/A	X Walk 1 Width (in)	110.0	N/A	X Walk 2 Width (in)	109.0
	X Walk 1 Slope (%)	3.2		X Walk 2 Slope (%)	0.1
	X Walk 1 X Slope (%)	2.4		X Walk 2 X Slope (%)	3.5

N/A	Ramp inside XWalk1?	Yes	N/A	Ramp inside XWalk2?	Yes
	Road Slope (%)	0.1	N/A	Clear Space?	N/A
	Road X Slope (%)	3.4	N/A	Clear Space to XWalk (in)	N/A
N/A	Any Obstructions?	N/A	N/A	Storm Grate/Utility Hazard?	N/A
	Obstruction Type			Storm Grate/Utility Type	
		N/A			N/A
		Yes		Surface Condition? (G/P)	Good

Possible Solutions:

Remove & Replace Curb Ramp With Two New Directional Ramps or Equivalent.
