Access Compliance Report

Public Rights-of-Way

(Curb Ramps)

Intersection ID: N/A	Main Street: BRECKFIELD_CT	Cross Street: HALKIRK_MANOR_LN	Location: SE
ADA ID: DAF266FC0763	Ramp Type: PerpDiag	Initial Pass/Fail: Fail	Overall Compliance: No
Severity Score: 21.25			
Codes/Mitigation Info/Possible Solution		Field Measurements/Component Compliance

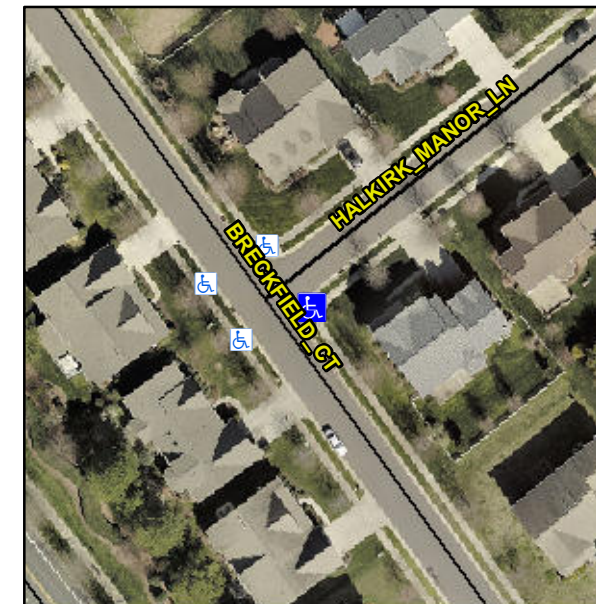
Not Found, R304.5.1, R304.2.2

Compliance	Description	Data	Compliance	Description	Data
N/A	Ramp Length (in)	49.0	No	Ramp Slope (%)	9.0
No	Ramp Width (in)	47.0	Yes	Ramp XSlope (%)	1.7
N/A	Flare Type LT	N/A	N/A	Flare Type RT	N/A
N/A	Flare Slope LT (%)	N/A	N/A	Flare Slope RT (%)	N/A
N/A	Flare Traversable LT?	N/A	N/A	Flare Traversable RT?	N/A
N/A	Landing Length (in)	N/A	N/A	DWS Provided?	N/A
N/A	Landing Width (in)	N/A	N/A	DWS Contrast?	N/A
N/A	Landing Slope (%)	N/A	N/A	DWS Length (in)	N/A
N/A	Landing X Slope (%)	N/A	N/A	DWS Full Width?	N/A
N/A	Landing Curb? (Y/N)	N/A	N/A	DWS Offset (in)	N/A
N/A	Shared Landing?	N/A			
N/A	Gutter Ponding?	N/A	N/A	Gutter Slope (%)	N/A
N/A	Gutter Lip Ht (in)	N/A	N/A	Gutter X Slope (%)	N/A
N/A	Painted X Walk1?	No	N/A	Painted X Walk2?	No
	X Walk 1 Direction	To NW		X Walk 2 Direction	To SW
N/A	X Walk 1 Width (in)	N/A	N/A	X Walk 2 Width (in)	N/A
	X Walk 1 Slope (%)	1.6		X Walk 2 Slope (%)	3.3
	X Walk 1 X Slope (%)	3.4		X Walk 2 X Slope (%)	1.4

N/A	Ramp inside XWalk1?	N/A	N/A	Ramp inside XWalk2?	N/A
	Road Slope (%)	1.4	N/A	Clear Space?	N/A
	Road X Slope (%)	0.2	N/A	Clear Space to XWalk (in)	N/A
N/A	Any Obstructions?	N/A	N/A	Storm Grate/Utility Hazard?	N/A
	Obstruction Type			Storm Grate/Utility Type	
		N/A			N/A
			Yes	Surface Condition? (G/P)	Good

Possible Solutions:

Remove & Replace Curb Ramp With Two New Directional Ramps or Equivalent.
