Access Compliance Report

Public Rights-of-Way

(Curb Ramps)

| Intersection ID: 42718 | Main Street: PICKEREL_LN | Cross Street: PLANTAIN_CT | Location: E |

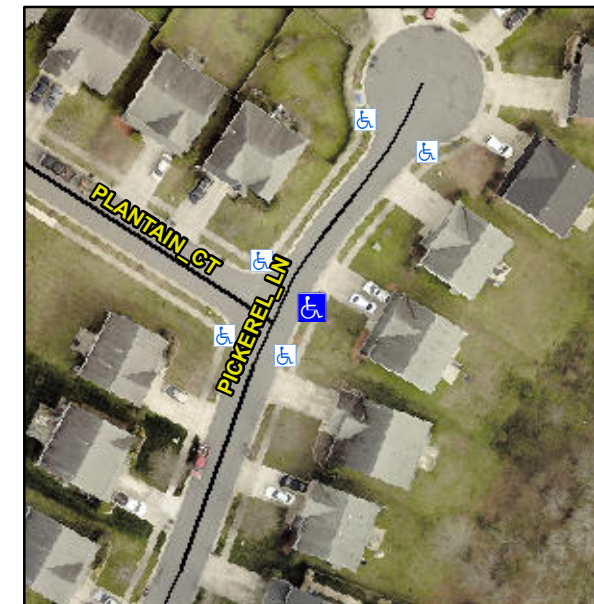
| ADA ID: DAF7105F4F70 | Ramp Type: Perp | Initial Pass/Fail: Fail | Overall Compliance: No |
| | | Severity Score: 10 | |

Not Found, R304.5.1

| Compliance | Description | Data | Compliance | Description | Data |
|---|---|---|---|---|---|
| N/A | Ramp Length (in) | 47.5 | Yes | Ramp Slope (%) | 5.8 |
| No | Ramp Width (in) | 47.5 | Yes | Ramp XSlope (%) | 3.3 |

Possible Solutions:

Remove & Replace Entire Ramp.

Total Cost: \$ 1850.00
