Access Compliance Report

Public Rights-of-Way

(Curb Ramps)

Intersection ID: 17066	Main Street: BRIARGATE_RD	Cross Street: MISSION_HILLS_RD	Location: NW
ADA ID: DAFA234B5077	Ramp Type: PerpDiag	Initial Pass/Fail: Fail	Overall Compliance: No
Severity Score: 25			
Codes/Mitigation Info/Possible Solution		Field Measurements/Component Compliance

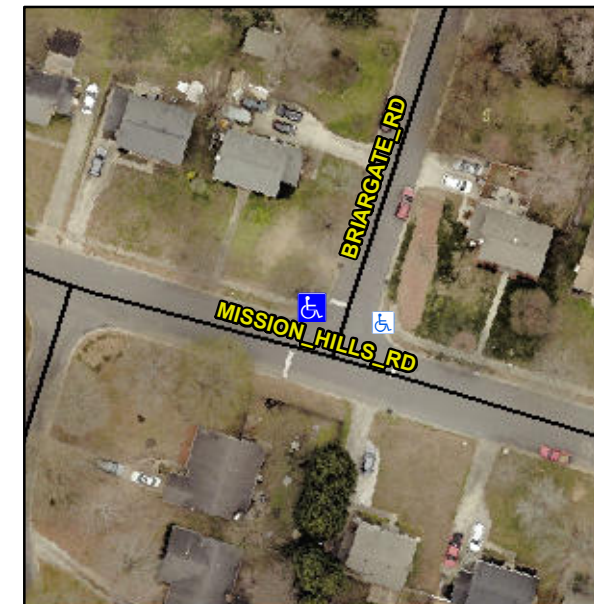
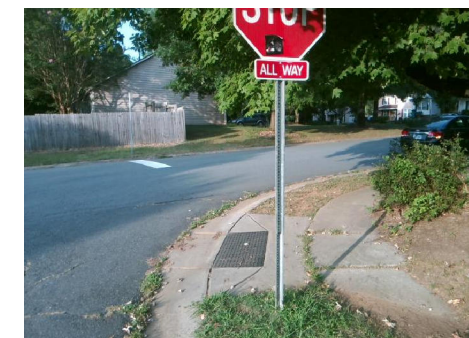
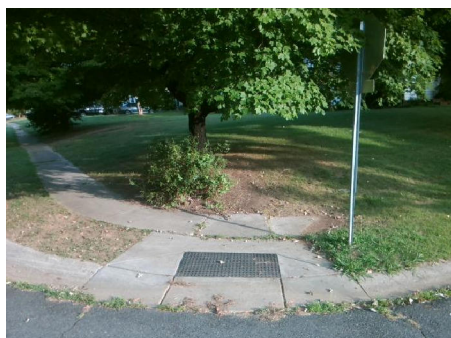
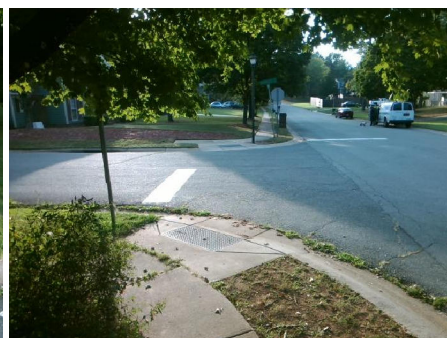
Compliance	Description	Data	Compliance	Description	Data
N/A	Ramp Length (in)	46.0	No	Ramp Slope (%)	8.6
Yes	Ramp Width (in)	48.0	No	Ramp XSlope (%)	5.7
N/A	Flare Type LT	N/A	N/A	Flare Type RT	N/A
N/A	Flare Slope LT (%)	N/A	N/A	Flare Slope RT (%)	N/A
N/A	Flare Traversable LT?	N/A	N/A	Flare Traversable RT?	N/A
N/A	Landing Length (in)	N/A	N/A	DWS Provided?	N/A
N/A	Landing Width (in)	N/A	N/A	DWS Contrast?	N/A
N/A	Landing Slope (%)	N/A	N/A	DWS Length (in)	N/A
N/A	Landing X Slope (%)	N/A	N/A	DWS Full Width?	N/A
N/A	Landing Curb? (Y/N)	N/A	N/A	DWS Offset (in)	N/A
N/A	Shared Landing?	N/A			
N/A	Gutter Ponding?	N/A	N/A	Gutter Slope (%)	N/A
N/A	Gutter Lip Ht (in)	N/A	N/A	Gutter X Slope (%)	N/A
N/A	Painted X Walk1?	No	N/A	Painted X Walk2?	No
	X Walk 1 Direction	To SW		X Walk 2 Direction	To SE
N/A	X Walk 1 Width (in)	N/A	N/A	X Walk 2 Width (in)	N/A
	X Walk 1 Slope (%)	2.1		X Walk 2 Slope (%)	0.2
	X Walk 1 X Slope (%)	1.8		X Walk 2 X Slope (%)	2.4

N/A	Ramp inside XWalk1?	N/A	N/A	Ramp inside XWalk2?	N/A
	Road Slope (%)	4.0	N/A	Clear Space?	N/A
	Road X Slope (%)	1.6	N/A	Clear Space to XWalk (in)	N/A
N/A	Any Obstructions?	N/A	N/A	Storm Grate/Utility Hazard?	N/A
	Obstruction Type			Storm Grate/Utility Type	
		N/A			N/A
			Yes	Surface Condition? (G/P)	Good

Remove & Replace Curb Ramp With Two New Directional Ramps or Equivalent.
