Access Compliance Report

Public Rights-of-Way

(Curb Ramps)

| Intersection ID: 10028924 | Main Street: IDLEWILD_RD | Cross Street: N/A | Location: NW |

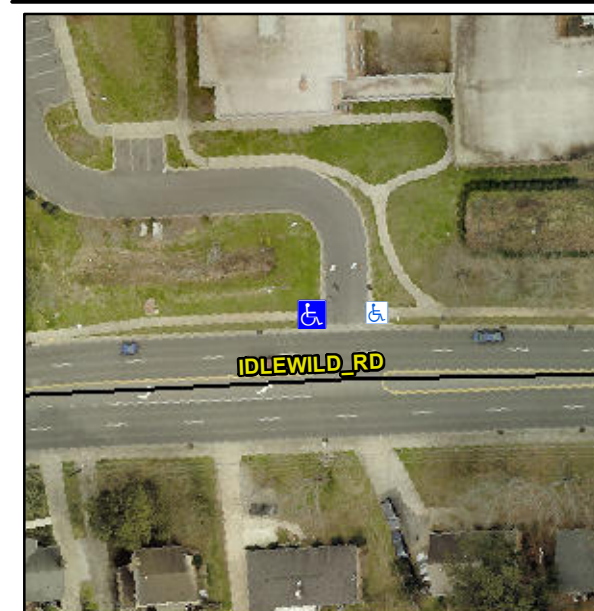
Not Found, R304.2.2, R304.5.3

| Compliance | Description | Data | Compliance | Description | Data |
|---|---|---|---|---|---|
| N/A | Ramp Length (in) | 45.0 | No | Ramp Slope (%) | 16.8 |
| Yes | Ramp Width (in) | 48.0 | No | Ramp XSlope (%) | 4.7 |

Remove & Replace Curb Ramp With Two New Directional Ramps or Equivalent.
