Access Compliance Report

Public Rights-of-Way

Intersection ID: 27649	Main Street: BALLANTYNE_COUNTRY_CLUB_DR	Cross Street: ROBINSON_ROCK_CT	Location: NW
ADA ID: DB0F3849AAF3	Ramp Type: Perp	Initial Pass/Fail: Fail	Overall Compliance: No
Severity Score: 12.5			
Codes/Mitigation Info/Possible Solution		Field Measurements/Component Compliance

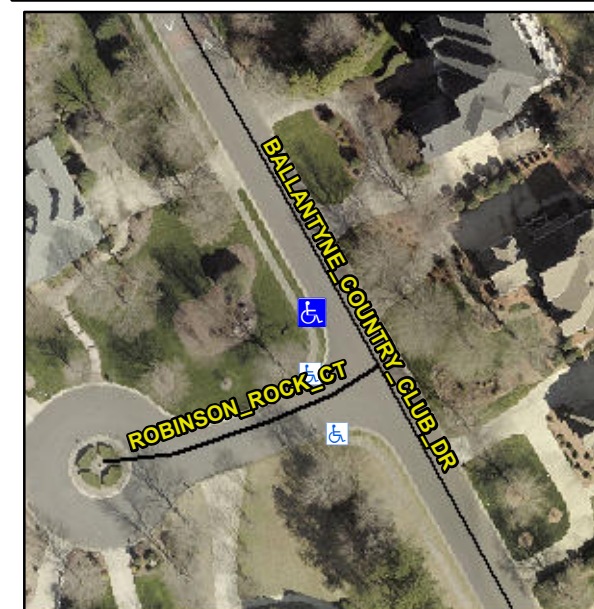
Not Found, R304.5.3

Compliance	Description	Data	Compliance	Description	Data
N/A	Ramp Length (in)	46.0	Yes	Ramp Slope (%)	6.7
Yes	Ramp Width (in)	48.0	No	Ramp XSlope (%)	5.9
N/A	Flare Type LT	N/A	N/A	Flare Type RT	N/A
N/A	Flare Slope LT (%)	N/A	N/A	Flare Slope RT (%)	N/A
N/A	Flare Traversable LT?	N/A	N/A	Flare Traversable RT?	N/A
N/A	Landing Length (in)	N/A	N/A	DWS Provided?	N/A
N/A	Landing Width (in)	N/A	N/A	DWS Contrast?	N/A
N/A	Landing Slope (%)	N/A	N/A	DWS Length (in)	N/A
N/A	Landing X Slope (%)	N/A	N/A	DWS Full Width?	N/A
N/A	Landing Curb? (Y/N)	N/A	N/A	DWS Offset (in)	N/A
N/A	Shared Landing?	N/A			
N/A	Gutter Ponding?	N/A	N/A	Gutter Slope (%)	N/A
N/A	Gutter Lip Ht (in)	N/A	N/A	Gutter X Slope (%)	N/A
N/A	Painted X Walk1?	No	N/A	Painted X Walk2?	N/A
	X Walk 1 Direction	To NE		X Walk 2 Direction	N/A
N/A	X Walk 1 Width (in)	N/A	N/A	X Walk 2 Width (in)	N/A
	X Walk 1 Slope (%)	2.1		X Walk 2 Slope (%)	N/A
	X Walk 1 X Slope (%)	4.6		X Walk 2 X Slope (%)	N/A

N/A	Ramp inside XWalk1?	N/A	N/A	Ramp inside XWalk2?	N/A
	Road Slope (%)	N/A	N/A	Clear Space?	N/A
	Road X Slope (%)	N/A	N/A	Clear Space to XWalk (in)	N/A
N/A	Any Obstructions?	N/A	N/A	Storm Grate/Utility Hazard?	N/A
	Obstruction Type			Storm Grate/Utility Type	
		N/A			N/A
			Yes	Surface Condition? (G/P)	Good

Possible Solutions:

Remove & Replace Entire Ramp.

Total Cost: \$ 1850.00
