Access Compliance Report

Public Rights-of-Way

(Curb Ramps)

Intersection ID: N/A	Main Street: FREEDOM_DR	Cross Street: N_I-85_RA	Location: N
ADA ID: DB1E64E8C722	Ramp Type: Directional1	Initial Pass/Fail: Pass	Overall Compliance: No
Severity Score: 15.25			
Codes/Mitigation Info/Possible Solution		Field Measurements/Component Compliance

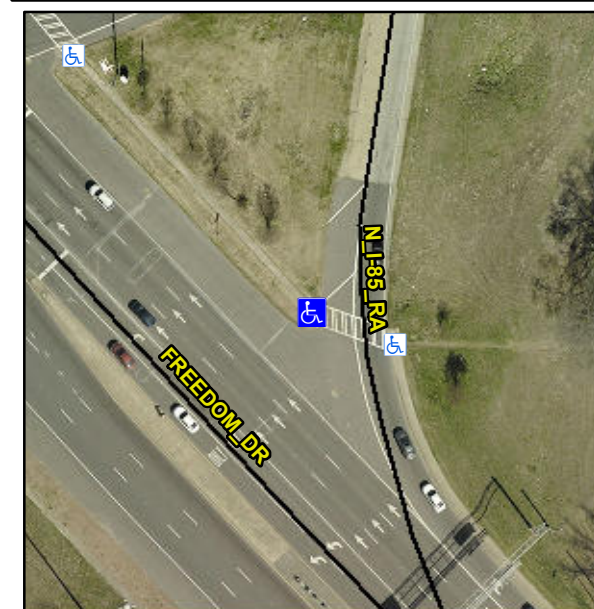
Compliance	Description	Data	Compliance	Description	Data
N/A	Ramp Length (in)	71.0	Yes	Grade Break?	Yes
Yes	Ramp Width (in)	60.0	Yes	Grade Break Slope (%)	0.8
Yes	Ramp Slope (%)	1.4	No	Grade Break XSlope (%)	3.1
No	Ramp XSlope (%)	3.2			
N/A	Flare Type LT	N/A	N/A	Flare Type RT	N/A
N/A	Flare Slope LT (%)	N/A	N/A	Flare Slope RT (%)	N/A
N/A	Flare Traversable LT?	N/A	N/A	Flare Traversable RT?	N/A
Yes	Landing Length (in)	61.0	Yes	DWS Provided?	Yes
Yes	Landing Width (in)	60.0	Yes	DWS Contrast?	Yes
Yes	Landing Slope (%)	1.8	Yes	DWS Length (in)	24.0
No	Landing X Slope (%)	3.5	Yes	DWS Full Width?	Yes
N/A	Landing Curb? (Y/N)	N/A	Yes	DWS Offset LT (in)	48.0
N/A	Shared Landing?	No	No	DWS Offset RT (in)	5.0
Yes	Gutter Ponding?	No	Yes	Gutter Slope (%)	2.3
No	Gutter Lip Ht (in)	1.0	Yes	Gutter X Slope (%)	1.4
N/A	Painted X Walk1?	Yes		Road Slope (%)	1.7
	X Walk 1 Direction	To SE		Road X Slope (%)	2.3
	X Walk 1 Width (in)	116.0		Clear Space?	Yes

X Walk 1 Slope (%)	1.7	N/A	Clear Space to XWalk (in)	N/A
	X Walk 1 X Slope (%)	2.3	Yes	Storm Grate/Utility Hazard?	No
Yes	Ramp inside XWalk1?	Yes		Storm Grate/Utility Type	
Yes	Any Obstructions?	No			N/A
	Obstruction Type		Yes	Surface Condition? (G/P)	Good
			N/A	Curb Slope (%)	4.5

Possible Solutions:

**Remove & Replace Entire Ramp.
Grind Gutter Lip.**
