Access Compliance Report

Public Rights-of-Way (Curb Ramps)

| Intersection ID: 43106 | Main Street: BRIARCLIFF_PL | Cross Street: SHARON_RD | Location: NW |
| ADA ID: DB22ECD368B2 | Ramp Type: Directional1 | Initial Pass/Fail: Fail | Overall Compliance: No |

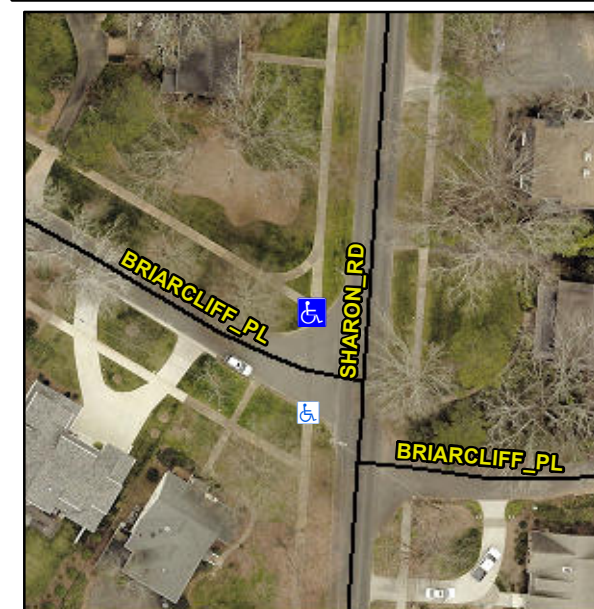
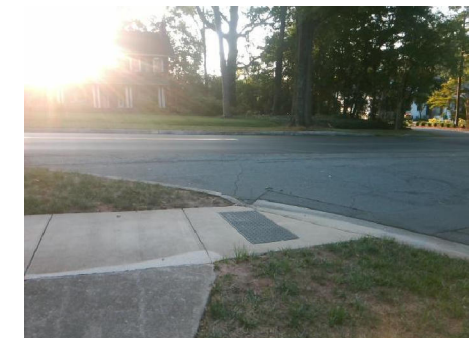
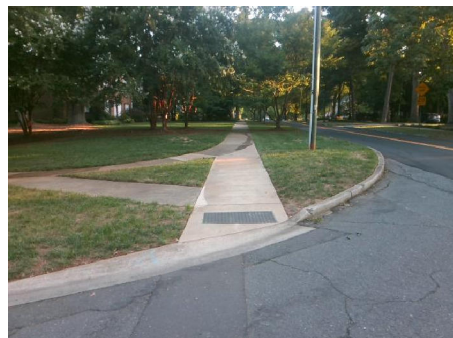
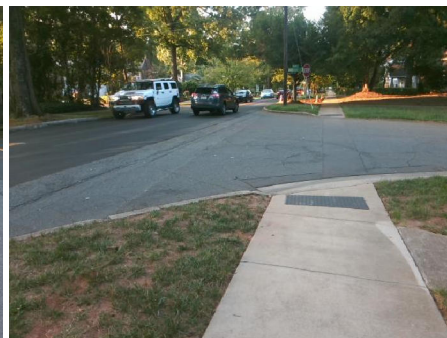
R304.2.2

| Compliance | Description | Data | Compliance | Description | Data |
|---|---|---|---|---|---|
| No | Ramp Slope (%) | 8.6 | N/A | Grade Break XSlope (%) | 0.0 |

Remove & Replace Entire Ramp.
