# Access Compliance Report

## Public Rights-of-Way

Intersection ID: 47851	Main Street: CACTUS_VALLEY_RD	Cross Street: SERAPE_RD	Location: NW
ADA ID: DB2AA2F78194	Ramp Type: PerpDiag	Initial Pass/Fail: Fail	Overall Compliance: No
		Severity Score: 8.75

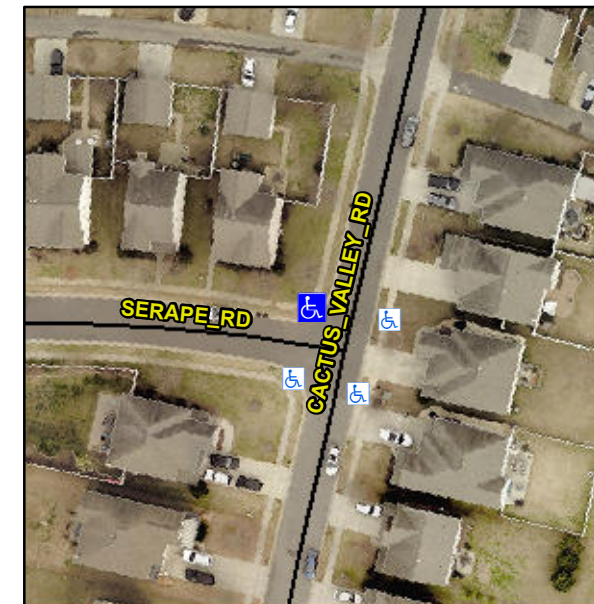
**Not Found, R304.5.1**

Compliance	Description	Data	Compliance	Description	Data
N/A	Ramp Length (in)	65.0	Yes	Ramp Slope (%)	5.2
No	Ramp Width (in)	45.0	Yes	Ramp XSlope (%)	1.7
N/A	Flare Type LT	N/A	N/A	Flare Type RT	N/A
N/A	Flare Slope LT (%)	N/A	N/A	Flare Slope RT (%)	N/A
N/A	Flare Traversable LT?	N/A	N/A	Flare Traversable RT?	N/A
N/A	Landing Length (in)	N/A	N/A	DWS Provided?	N/A
N/A	Landing Width (in)	N/A	N/A	DWS Contrast?	N/A
N/A	Landing Slope (%)	N/A	N/A	DWS Length (in)	N/A
N/A	Landing X Slope (%)	N/A	N/A	DWS Full Width?	N/A
N/A	Landing Curb? (Y/N)	N/A	N/A	DWS Offset (in)	N/A
N/A	Shared Landing?	N/A			
N/A	Gutter Ponding?	N/A	N/A	Gutter Slope (%)	N/A
N/A	Gutter Lip Ht (in)	N/A	N/A	Gutter X Slope (%)	N/A
N/A	Painted X Walk1?	No	N/A	Painted X Walk2?	No
	X Walk 1 Direction	To SW		X Walk 2 Direction	To SE
N/A	X Walk 1 Width (in)	N/A	N/A	X Walk 2 Width (in)	N/A
	X Walk 1 Slope (%)	0.5		X Walk 2 Slope (%)	2.5
	X Walk 1 X Slope (%)	1.5		X Walk 2 X Slope (%)	0.5

N/A	Ramp inside XWalk1?	N/A	N/A	Ramp inside XWalk2?	N/A
	Road Slope (%)	0.5	N/A	Clear Space?	N/A
	Road X Slope (%)	2.6	N/A	Clear Space to XWalk (in)	N/A
N/A	Any Obstructions?	N/A	N/A	Storm Grate/Utility Hazard?	N/A
	Obstruction Type			Storm Grate/Utility Type	
		N/A			N/A
			Yes	Surface Condition? (G/P)	Good

**Remove & Replace Curb Ramp With Two New Directional Ramps or Equivalent.**
